Re: Consent Decree Case No. 2:05-cv-00199-WOB

Nine Minimum Controls 2013 Annual Compliance Report

Nine Minimum Controls 2013 Annual Compliance Report
Consent Decree Case No. 2:05-cv-00199-WOB

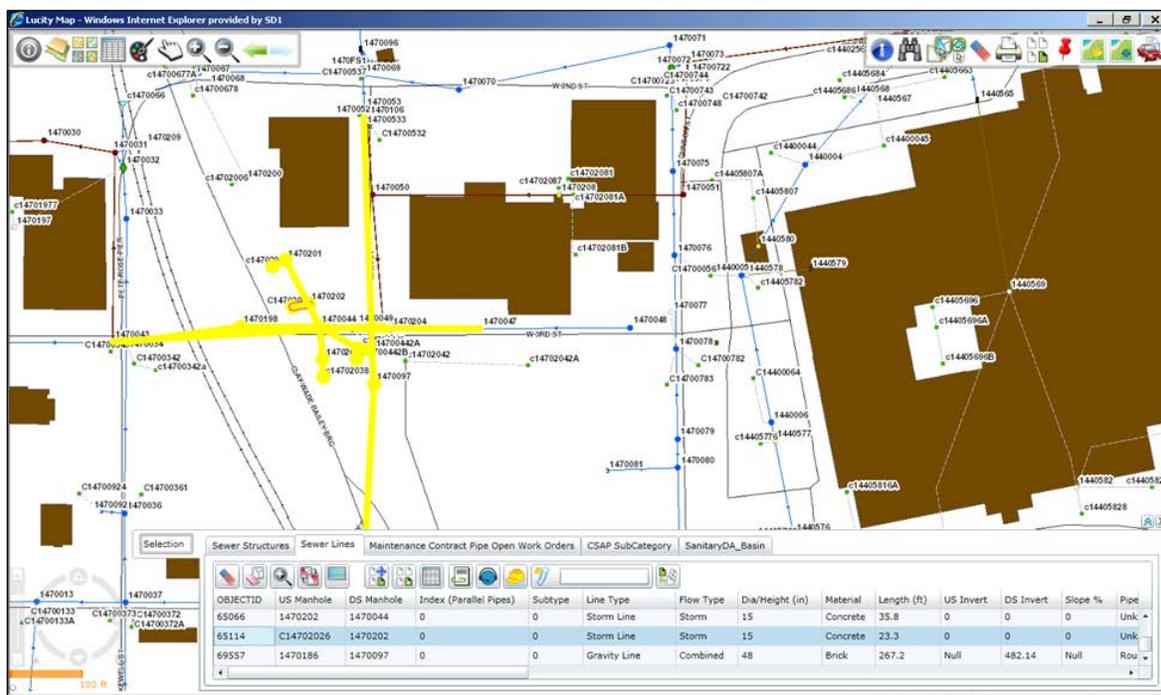
Figure 2.1 Lucy Dashboard

SD1 has continued improving its computerized maintenance management system, Lucy, with the addition of a dashboard application in 2012, which provides Collection Systems personnel greater flexibility with operation and maintenance (O&M) activities. The Lucy Dashboard is capable of map-based asset management, which allows planning and maintenance personnel to create and schedule work orders with greater ease. The new Lucy Dashboard also extends the functionality of a GIS-based asset management tool to employees that have not had access to these capabilities in the past, due to licensing limitations. In 2012, 90 employees in six departments were trained to use the Lucy Dashboard. Figure 2.1 displays how map-selected assets in the Lucy Dashboard (highlighted in yellow) can have work requests and orders assigned to them.

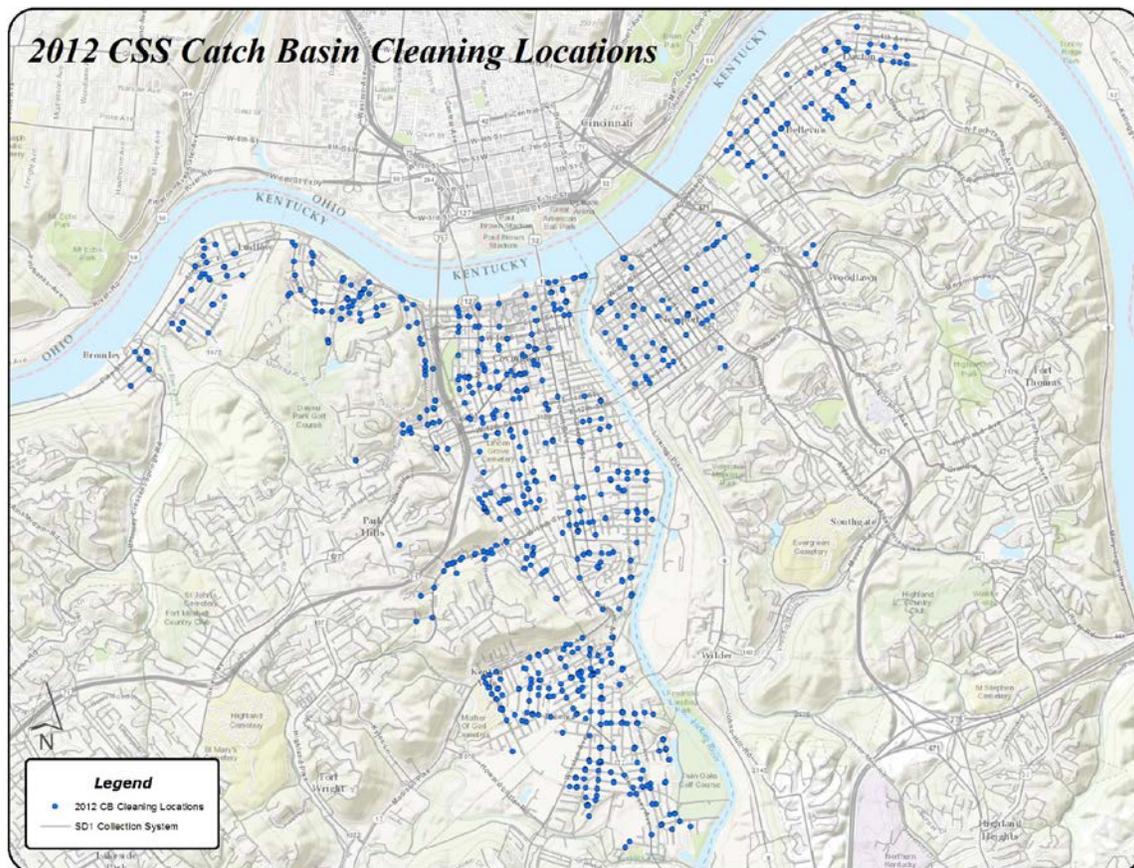
Figure 2.2 2012 CSS Catch Basin Cleaning Locations

SD1 performed 3,676 inspections of its own catch basins during 2012, and performed more than 1400 cleanings at approximately 805 locations. Figure 2.2 displays the approximate 805 locations that were cleaned during 2012. SD1 continues to review its

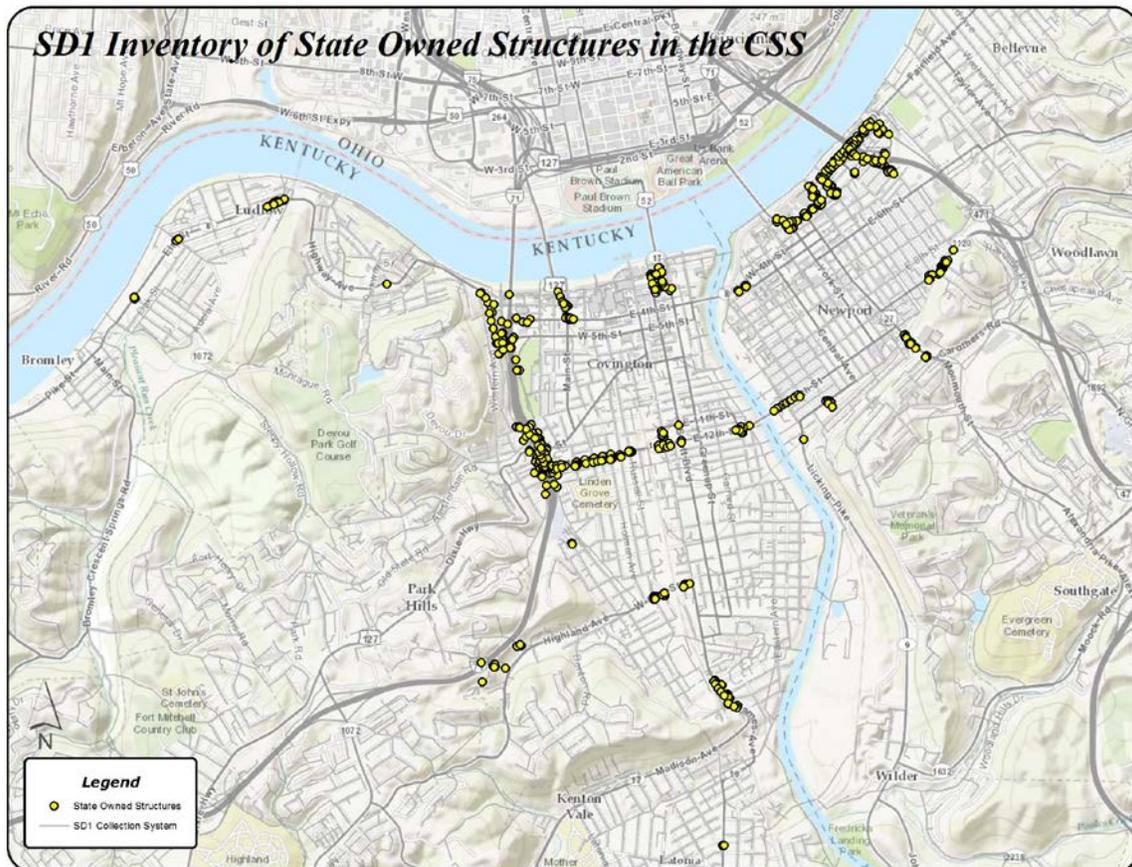
Figure 2.3 SD1 Inventory of KTC-Owned Structures in the CSS

structures has been verified with KTC, negotiations for a maintenance contract between SD1 and KTC will be finalized. SD1 inspected 44 KTC-owned catch basins in 2012 and continued to document maintenance needs. Figure 2.3 demonstrates the locations of all suspected KTC-owned structures in the CSS.

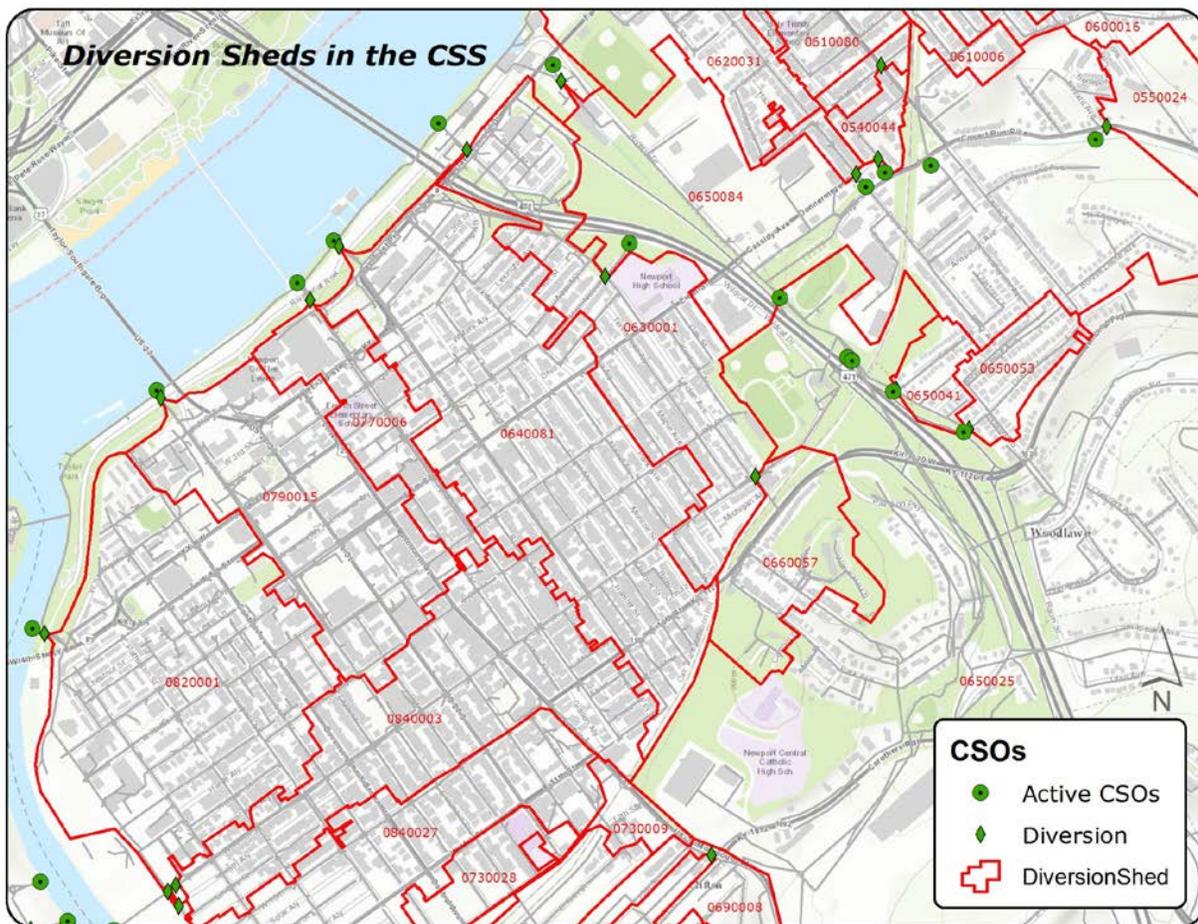
Figure 2.4 Diversion Sheds in the CSS

Figure 2.4 on the next page provides an example of the diversion sheds delineated in Newport and Bellevue.

The total footage of pipe inspected and cleaned, and the amount of debris and grit removed as part of the LDSAP Diversion sub-program, is included in the O&M data presented in Appendix A.

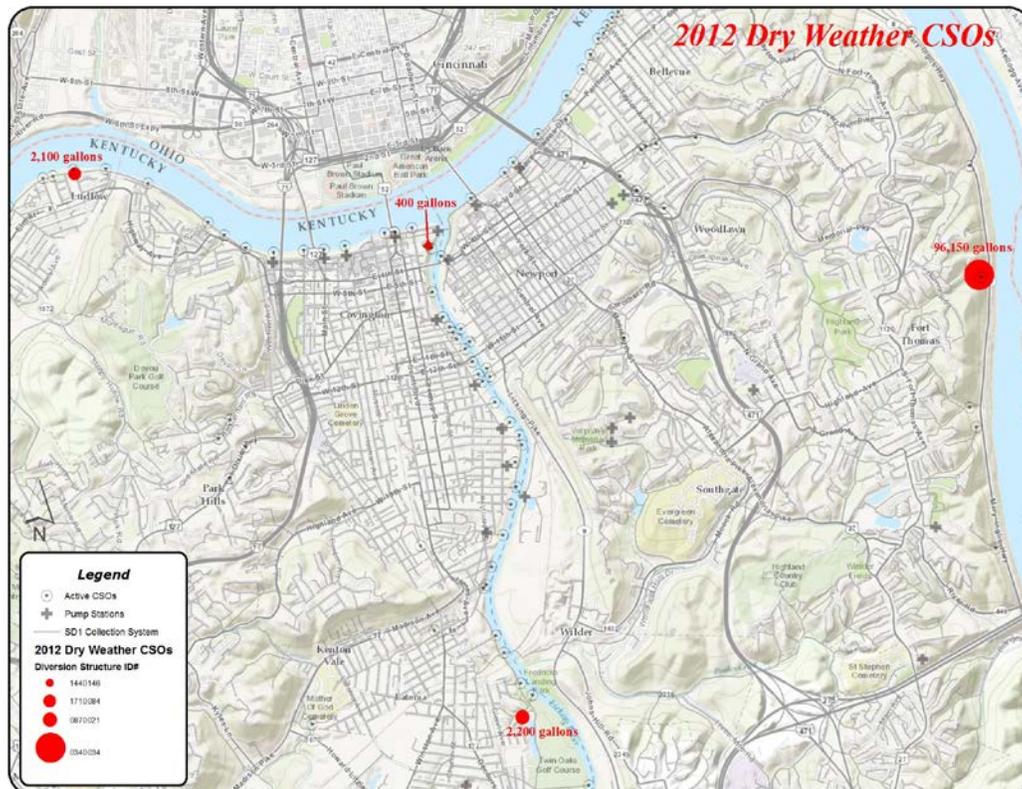
Figure 2.6 Locations of Observed Dry Weather CSOs in 2012

Figure 2.6 illustrates the locations of the dry-weather CSOs that occurred in 2012. A summary of the four dry-weather CSOs, including the locations, causes of overflows, estimated overflow volumes, and the actions taken to prevent the overflows from reoccurring is provided on the following page in Table 2.1. A more thorough description of the overflow events can be found in SD1’s 2012 quarterly reports submitted to the Cabinet and EPA.

Structure ID#	Location	Date	Overflow Cause	Estimated Volume	Corrective Action Taken
0870021	East 38 th Street, CSO Diversion	2/6/12	Blockage of Debris	2,200 gallons	The debris was removed from the line and re-inspected to ensure the blockage was completely cleared. The catch basins in the drainage area were inspected and retrofitted/ replaced with bells to reduce the amount of solids and floatables entering the system. The pipe was re-inspected and reassessed in 6 months as part of CSAP.
0340034	Lester Lane, CSO Diversion	3/14/12	Corrosion of Manhole	96,150 gallons	Bypass pumping was required to make an entry of the manhole. The damaged section of the manhole was sealed and will continue to be regularly inspected as part of SD1's CSO diversion inspection routine.
1440146	Kennedy Street, CSO Diversion	6/19/12	Blockage of Debris	400 gallons	The debris was removed from the line and re-inspected to ensure the blockage was completely cleared. Debris was also removed from the netbag at the outfall. It was determined that a flat grade of the line contributed to the blockage. The line was put on a more frequent cleaning schedule to prevent future debris.

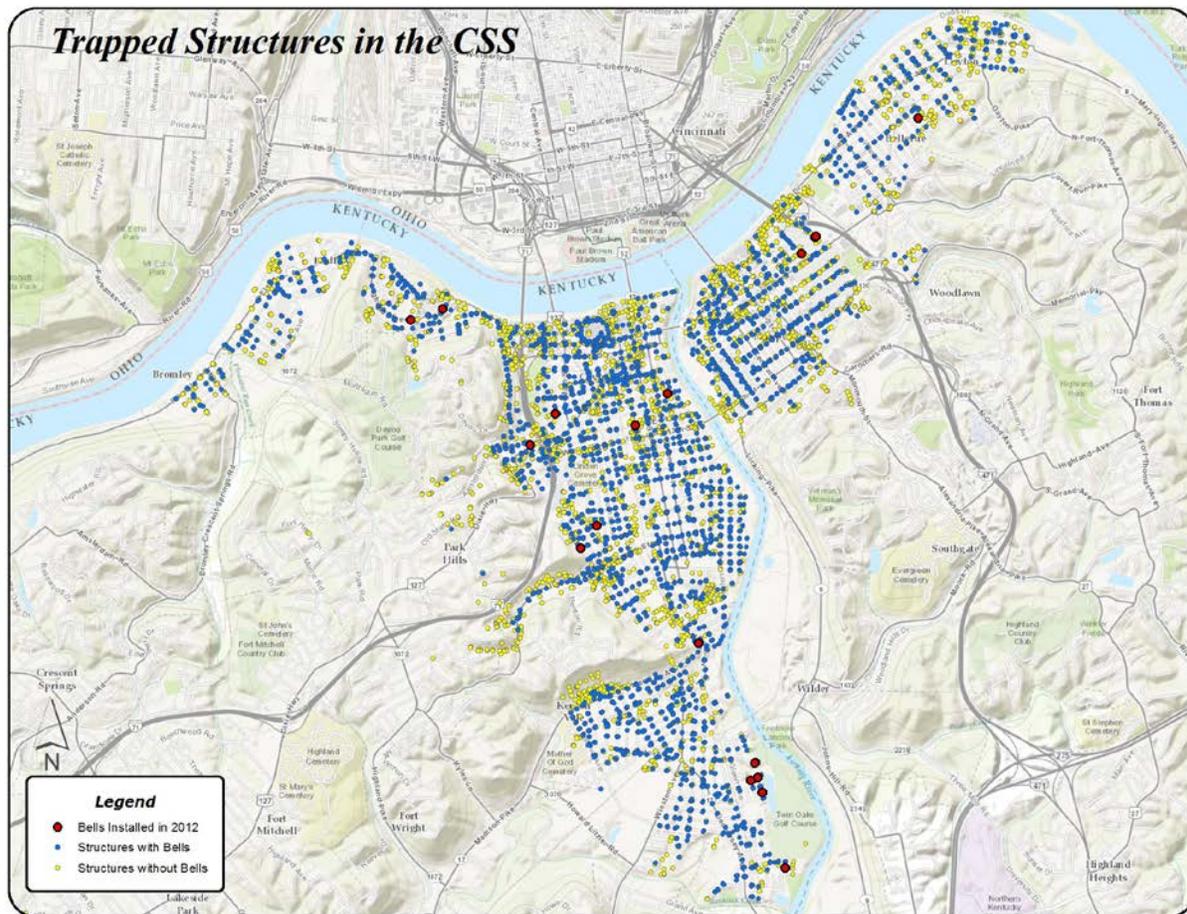
Figure 2.7 Trapped Structures in the CSS

From January 1, 2012 to December 31, 2012, SD1 performed 38 catch basin repairs and installed bells at 19 locations. SD1 also replaced 61 catch basins in the CSS. Of the known 5,781 public and private catch basins and inlets in the CSS, currently, 2,665 of the structures are fitted with a trap for solids and floatables control. Figure 2.7 illustrates the general locations of all trapped structures, including the 19 bells installed in 2012.

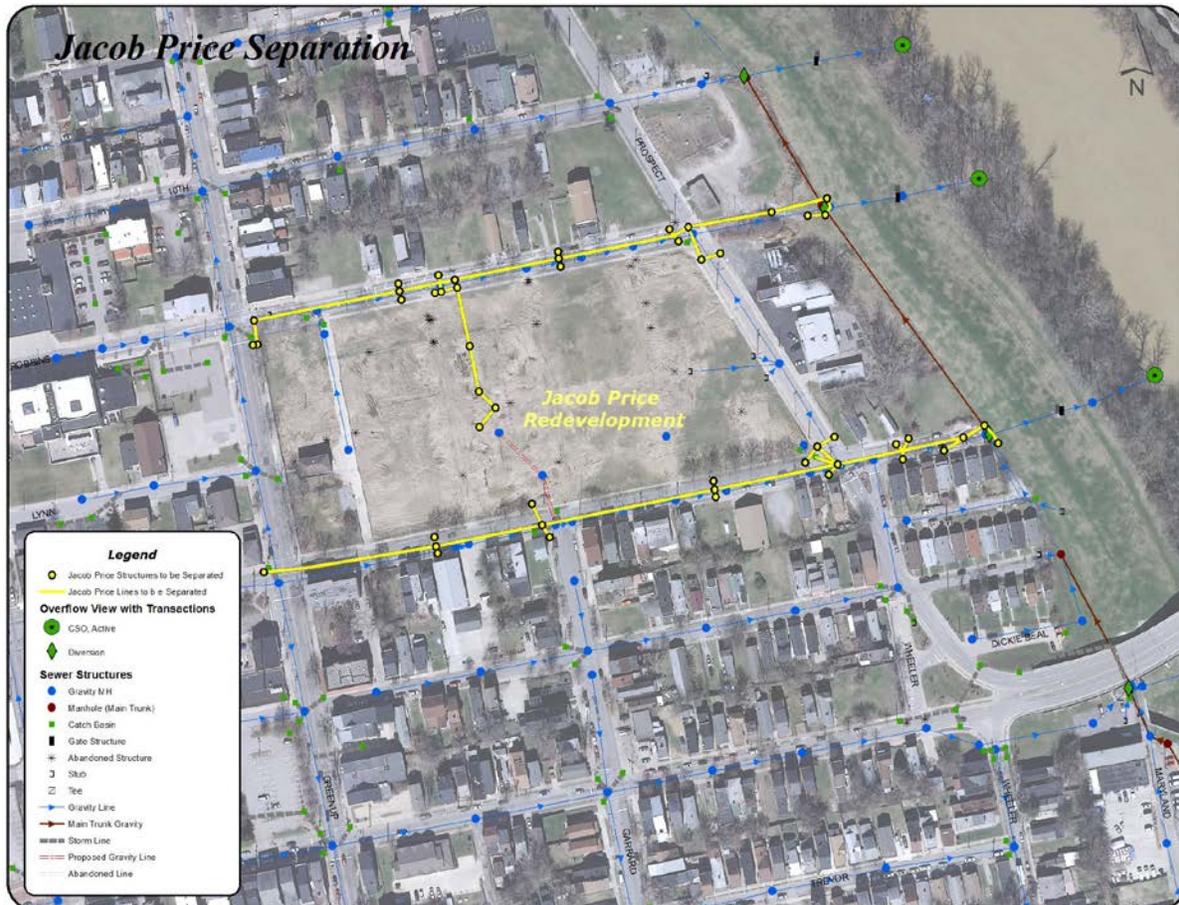
Figure 2.8 Proposed Jacob Price Separation

two CSO diversions and reconnection below the diversions on the outfall line. In total, 33 catch basins will be separated, trapped, and rerouted into the Robbins Street and 11th Street CSO outfalls along the Licking River. Figure 2.8 highlights the planned separated catch basins along two city blocks in yellow, and the reconnections to the outfalls between the diversion and the flood wall.

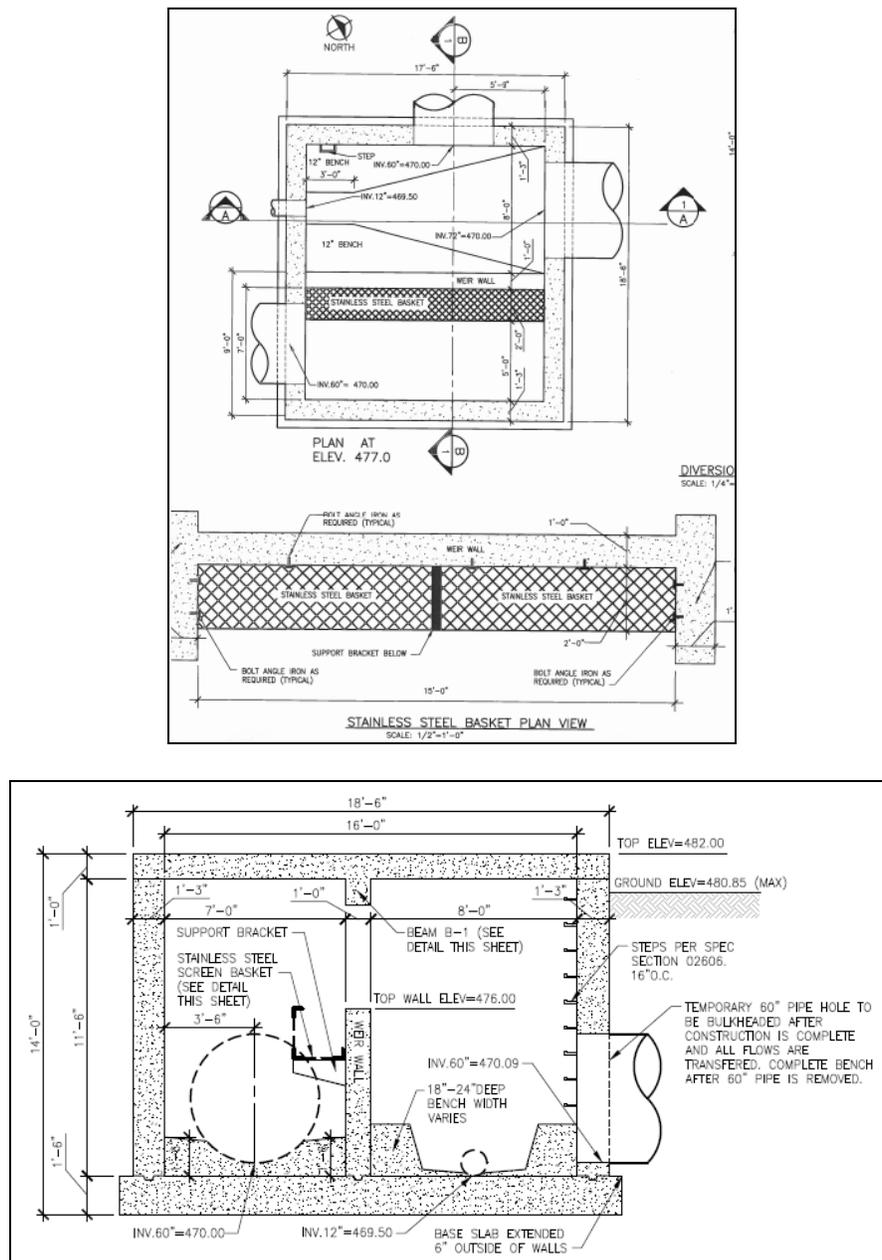
Figure 2.9 Draft Church Street Floatables Control Structure

The Church Street project was under design in 2012, and construction is anticipated to begin in the last quarter of 2013. The updated draft Church Street solids and floatables control structure is shown in Figure 2.9.
