WATERSHED TREND REPORT

CENTRAL STUDY BASIN

2012 - 2019

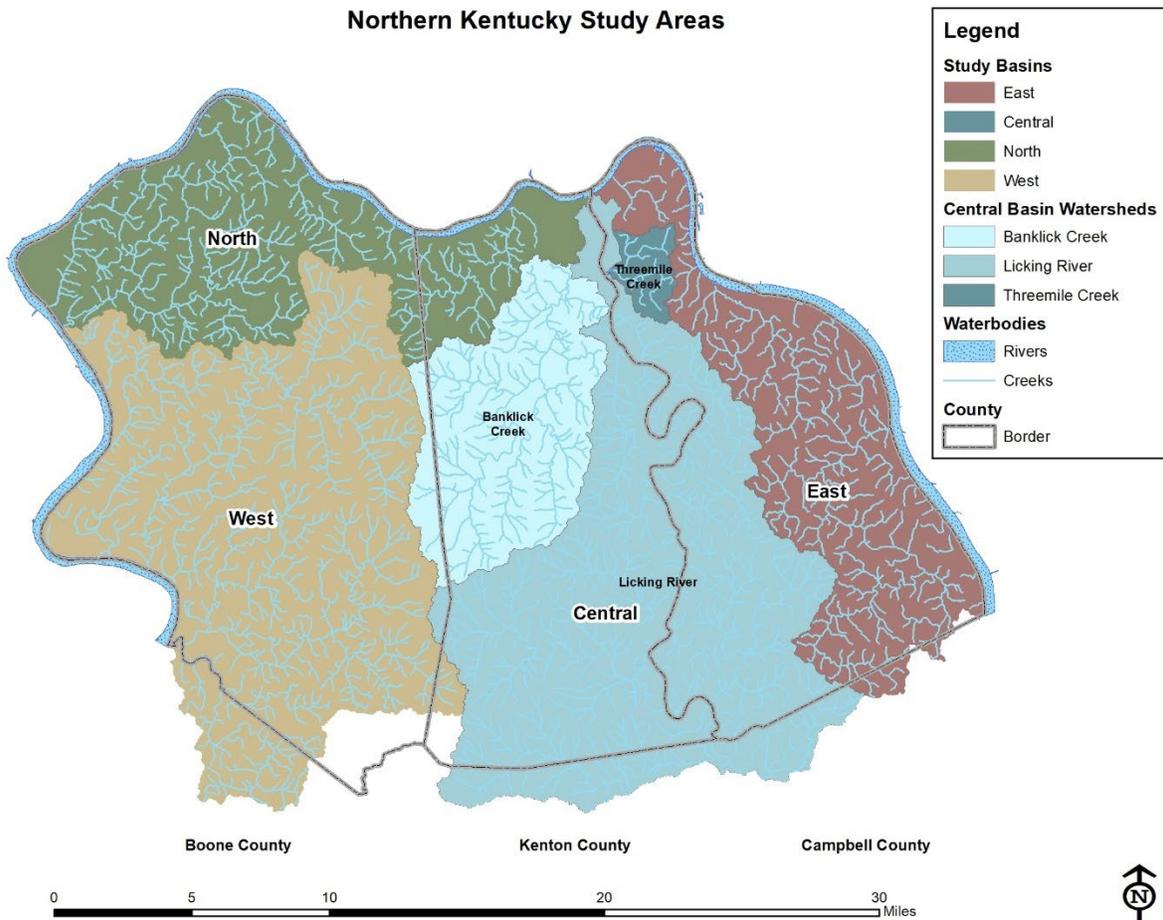
Figure 2. Central Basin Study Area Map

The Central Basin study area is located in all three Northern Kentucky counties, but the majority of the area is in Kenton County (Figure 2). This basin includes the lower portion of the Licking River watershed: the mainstem of the Licking River, along with Threemile Creek, Banklick Creek and other smaller tributaries that discharge directly to the Licking River.

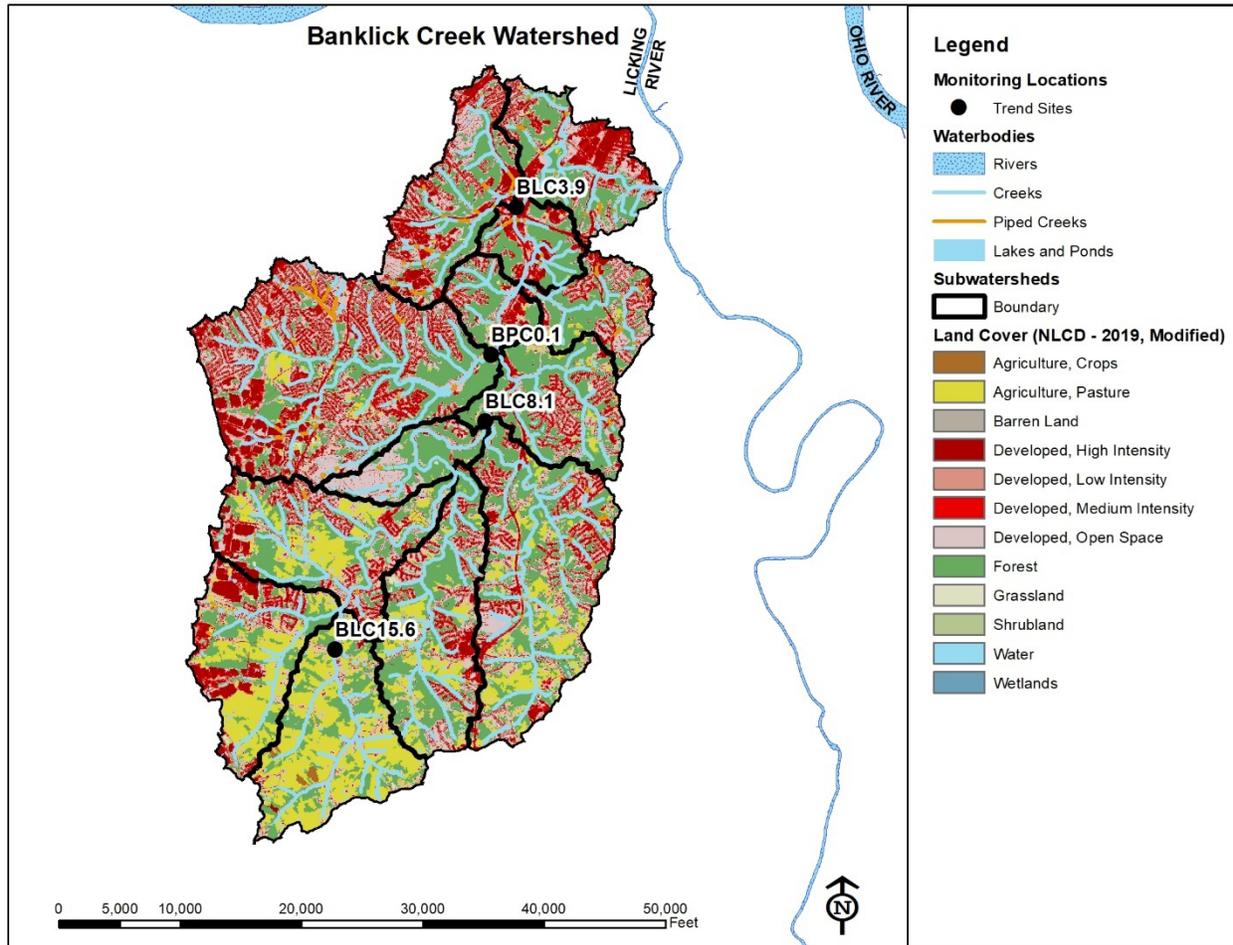
Figure 4. Banklick Creek Land Cover

Banklick Creek watershed consists mostly of suburban areas, with some highly urbanized areas in the lower portion of the watershed and some rural areas in the upper portion of the watershed (Figure 4). Land cover consists of predominately developed land (~51%), with lesser amounts of forested land (~32%) and pastureland (~14%). Interstate highway I-275, a significant transportation route, traverses the lower portion of the watershed.

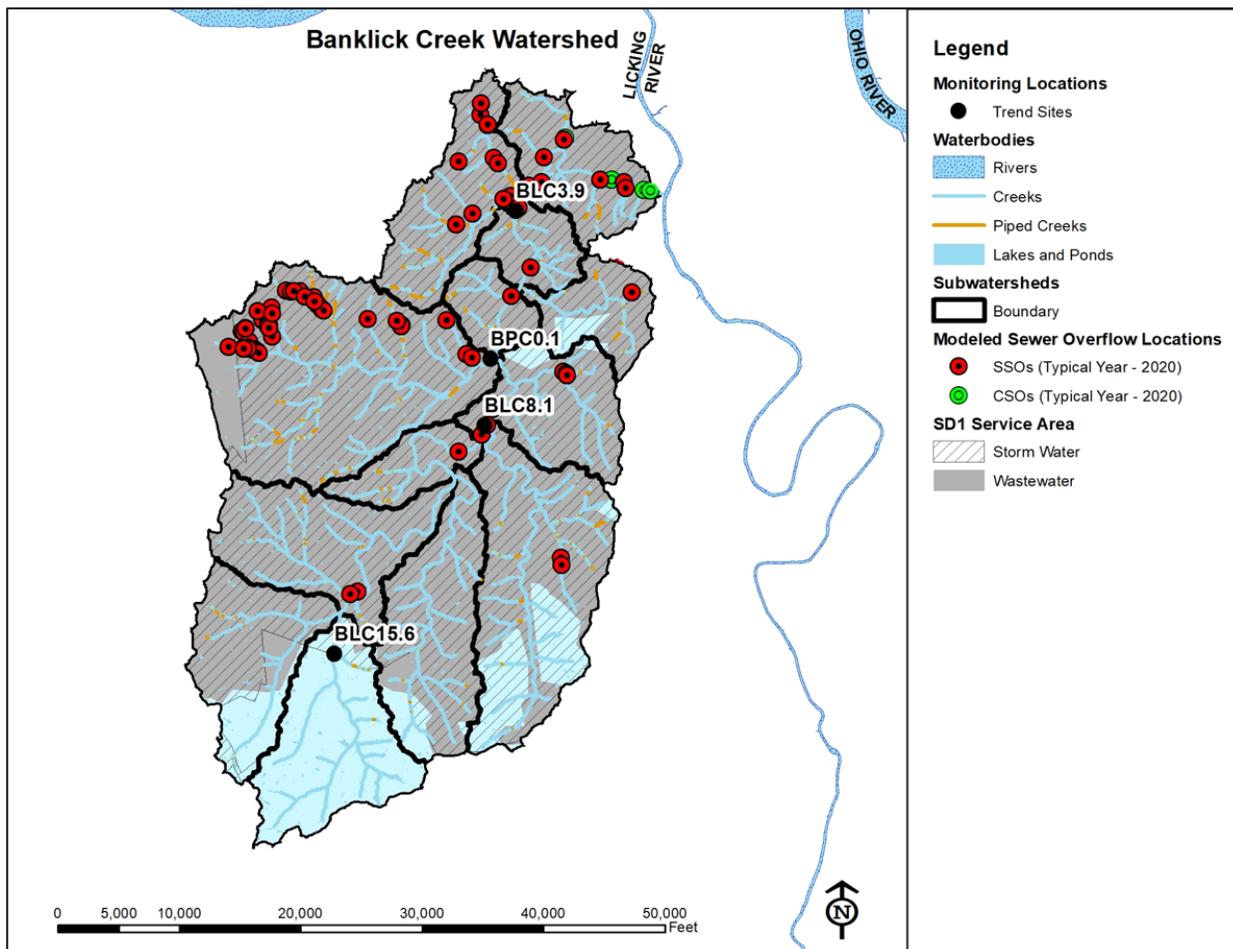
Figure 5. Banklick Creek Modeled Sewer Overflows and Service Areas

Areas within the Banklick Creek watershed that are managed by SD1 with respect to centralized sanitary sewers and regional storm water systems, are depicted in Figure 5. Currently within the wastewater system 79 modeled overflow locations, consisting of 75 sanitary sewer overflows (SSOs) and four combined sewer overflows (CSO), discharge during various wet weather conditions. CSO locations occur in the lower portion of the watershed near the Licking River, while the largest number of SSO locations occur in the Bullock Pen sub-watershed. Most of the watershed, except for the headwaters of Banklick Creek, is subject to Kentucky's Phase II MS4 program. The majority of the MS4 program area is encompassed within SD1's storm water service area, representing the NKY Regional Storm Water Program, while area within the city limits of Florence is subject to the city's storm water program. KYTC rights-of-way within the MS4 program area are subject to the Transportation Cabinet's storm water program.

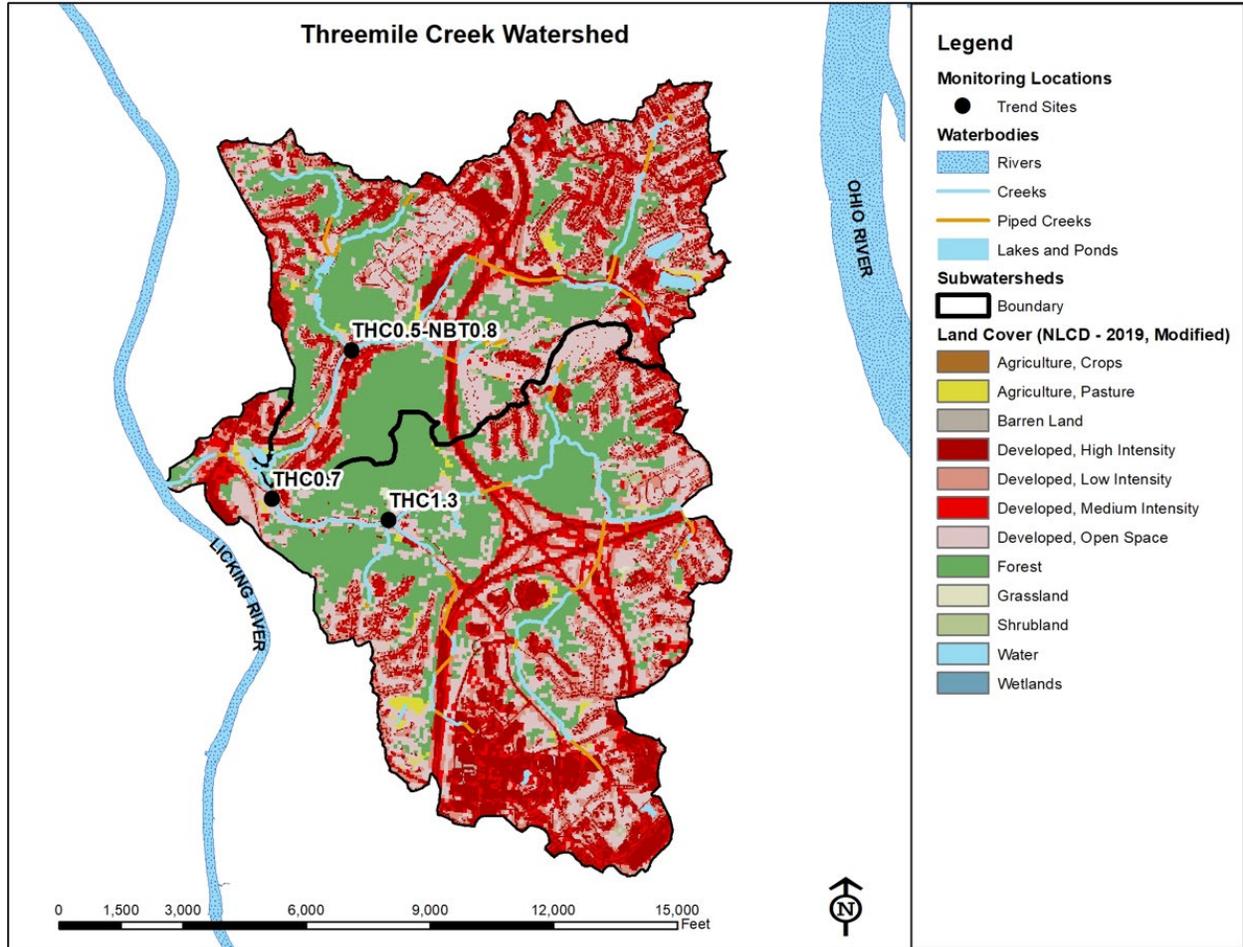
Figure 7. Threemile Creek Land Cover

Threemile Creek watershed is highly urbanized and the most developed watershed in the Central Basin (Figure 7). Land cover consists of predominately developed land (~71%), followed by forested land (~26%). Interstate highways I-471 and I-275, significant transportation routes, traverse sizable areas of the watershed.

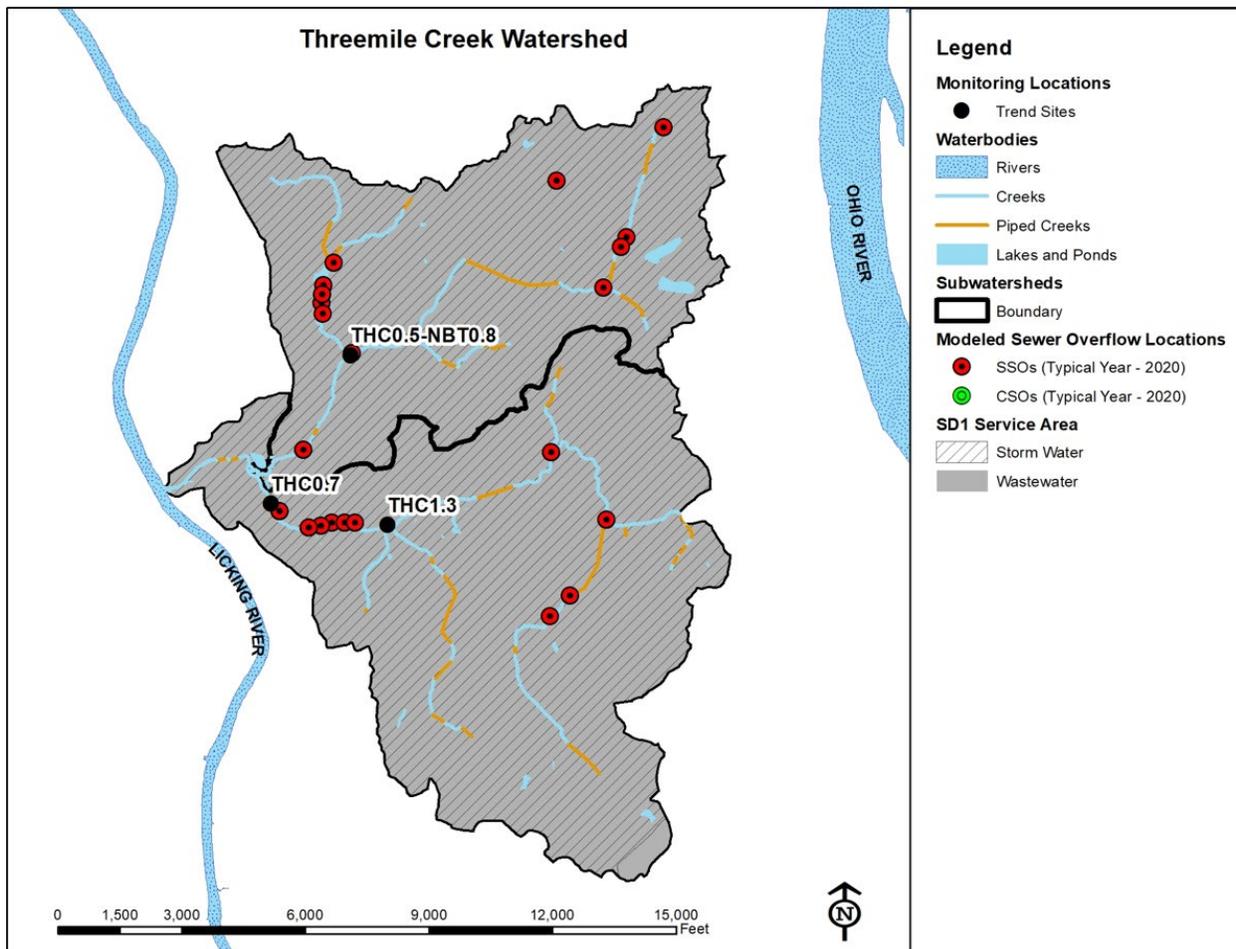
Figure 8. Threemile Creek Modeled Sewer Overflows and Service Areas

Areas within the Threemile Creek watershed that are managed by SD1 with respect to centralized sanitary sewers and regional storm water systems, are depicted in Figure 8. Currently within the wastewater system 22 modeled overflow locations, consisting of only sanitary sewer overflows (SSOs), discharge during various wet weather conditions. The overflow locations occur throughout the watershed. The entire watershed is subject to Kentucky's Phase II MS4 program. The majority of the MS4 program area is encompassed within SD1's storm water service area, representing the NKY Regional Storm Water Program, while area within the city limits of Cold Spring is subject to the city's storm water program. KYTC rights-of-way within the MS4 program area are subject to the Transportation Cabinet's storm water program.

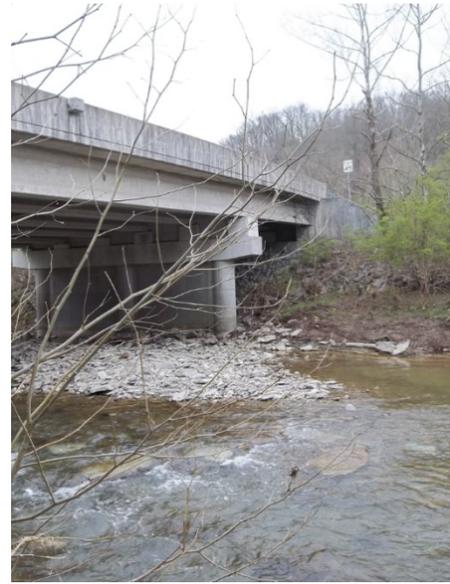
Photo 4. Banklick Creek 8.1

E. coli values ranged from 212 mpn/100ml to 24,200 mpn/100ml during Period 2 and ranged from 12 mpn/100ml to 24,200 mpn/100ml during Period 3 at BLC8.1. The median values during both periods were above the 240 mpn/100ml criteria, 434 and 276 mpn/100ml.

The median bacteria value for each reporting period was lowest within the Banklick Creek watershed when compared to the other Central Basin watershed. Suspected sources of elevated *E. coli* values within Banklick Creek watershed primarily includes sewer overflows, failing septic systems and storm water runoff.

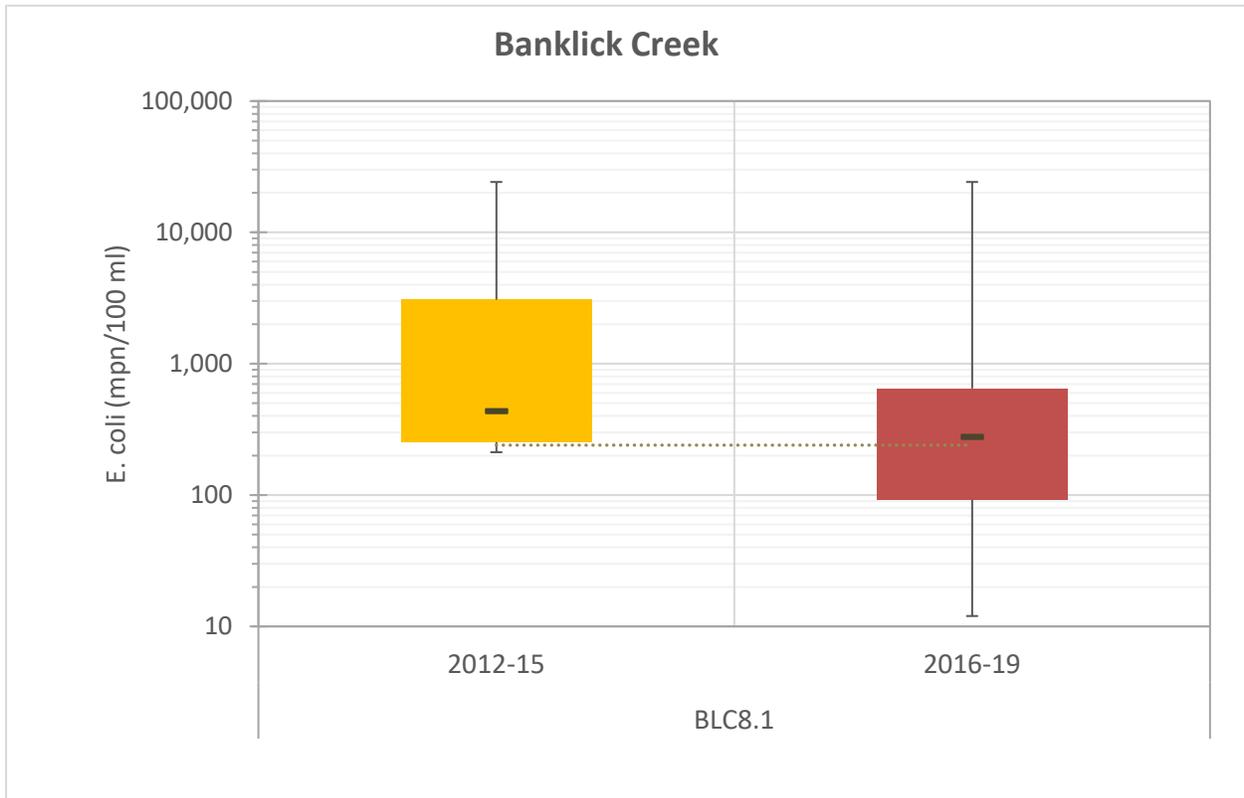
Figure 9. Banklick Creek *E. coli* Results

Note: The dashed line in the graph represents the single sample maximum criteria of 240 mpn/100ml.

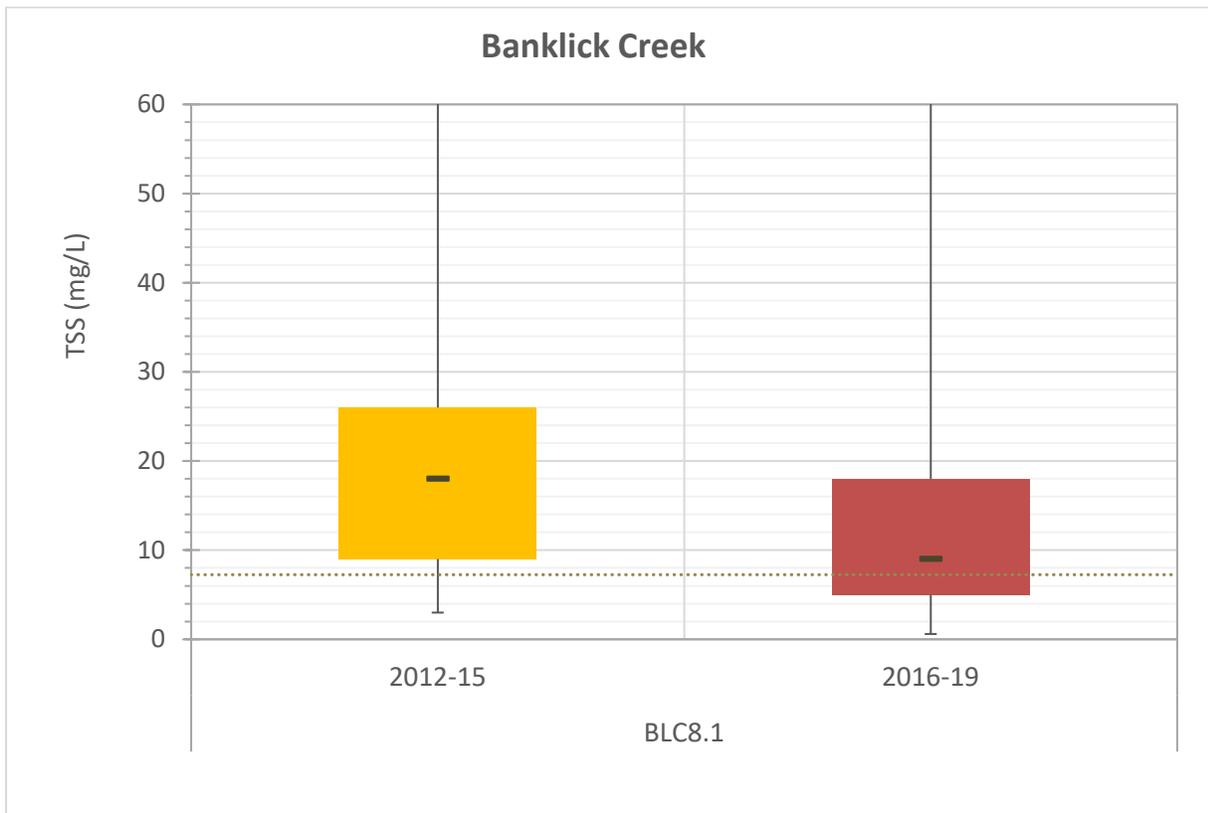
The median TSS value for each reporting period was the highest within the Banklick Creek watershed when compared to the other Central basin watershed. Suspected sources of elevated TSS values within the Banklick Creek watershed primarily includes storm water runoff and streambank erosion due to hydromodification.

Note: The dashed line in the graph represents the benchmark value established by KDOW of 7.25 mg/L.

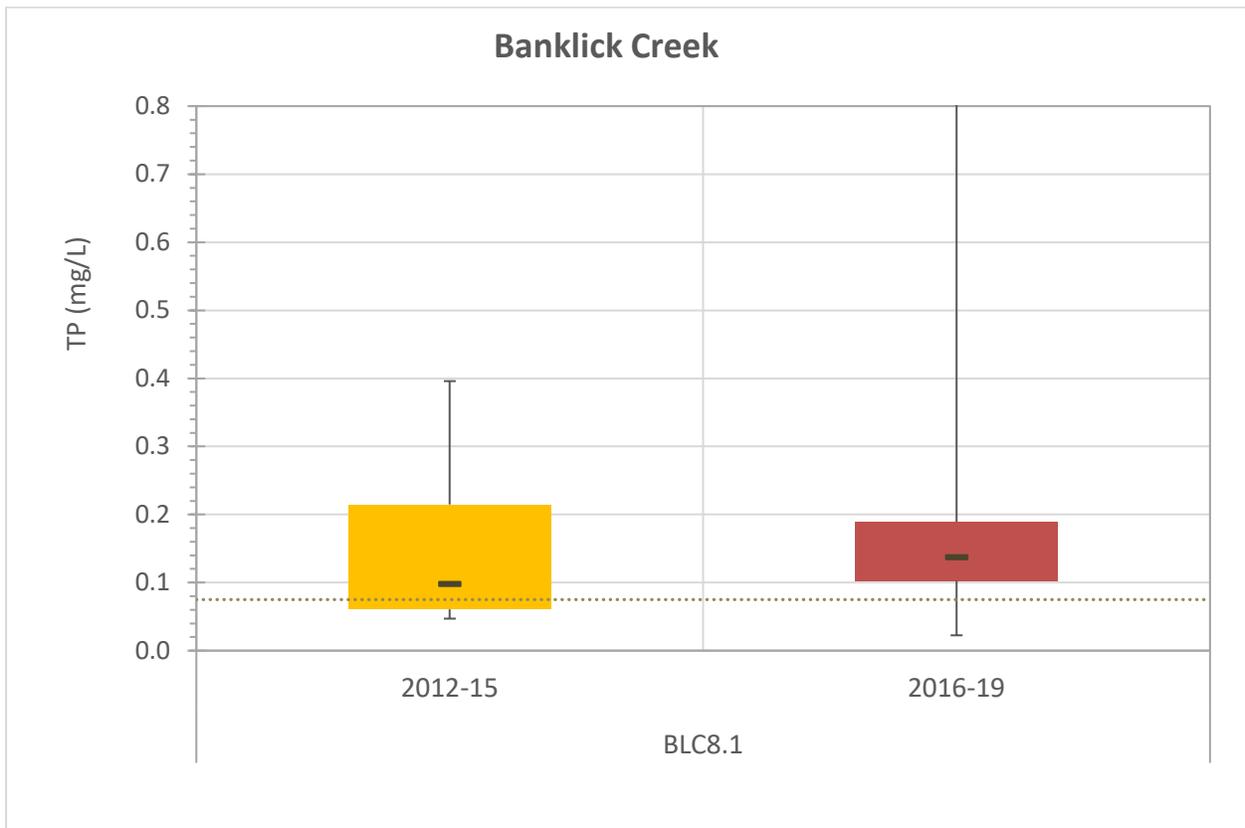
The median TP value for each reporting period was highest within the Banklick Creek watershed when compared to the other Central Basin watershed. Suspected sources of elevated phosphorus values within the Banklick Creek watershed primarily includes sewer overflows and storm water runoff.

Note: The dashed line in the graph represents the benchmark value established by KDOW of 0.08 mg/L.

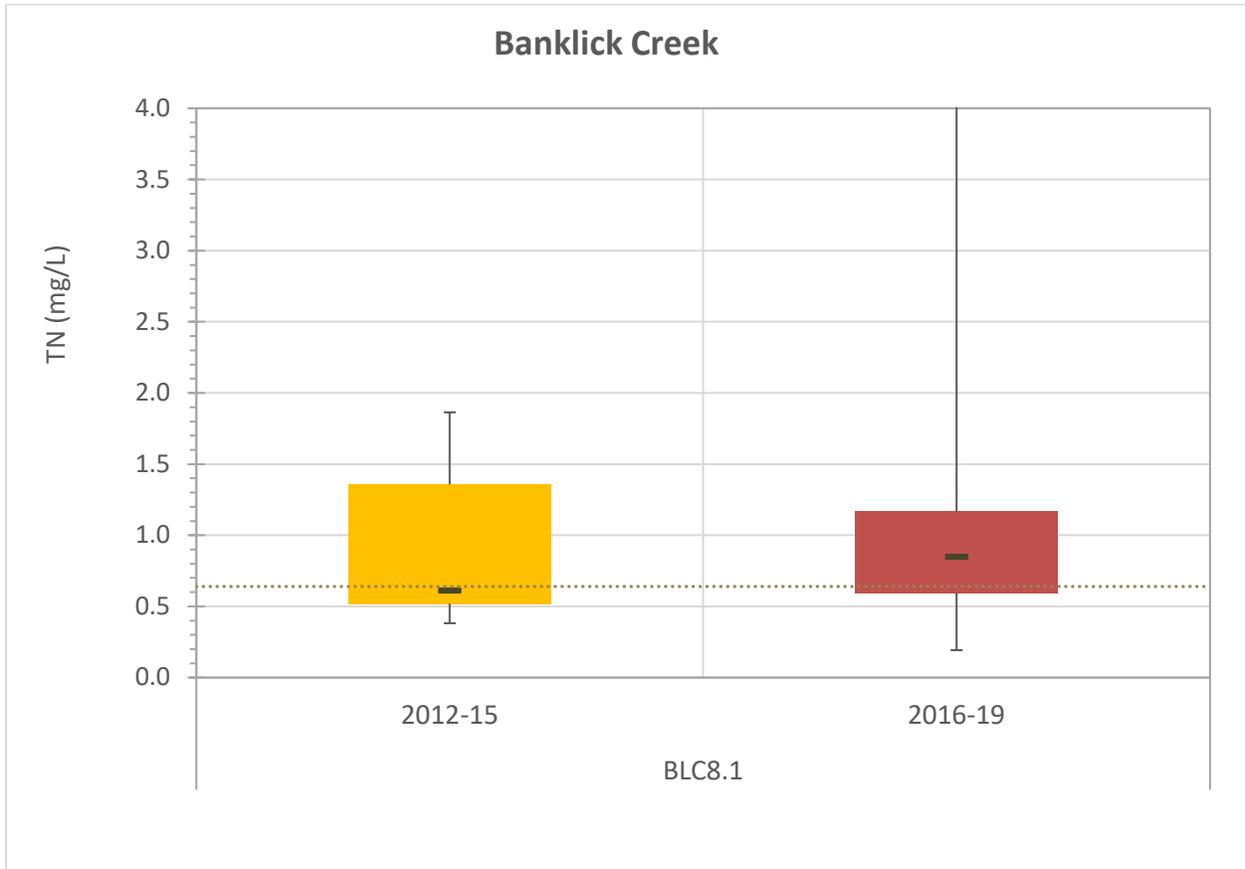
The median TN value for each reporting period was highest within the Banklick Creek watershed when compared to the other watershed in the Central Basin. Suspected sources of excess nitrogen values within Banklick Creek watershed primarily include storm water runoff.

Note: The dashed line in the graph represents the benchmark value established by KDOW of 0.6 mg/L.

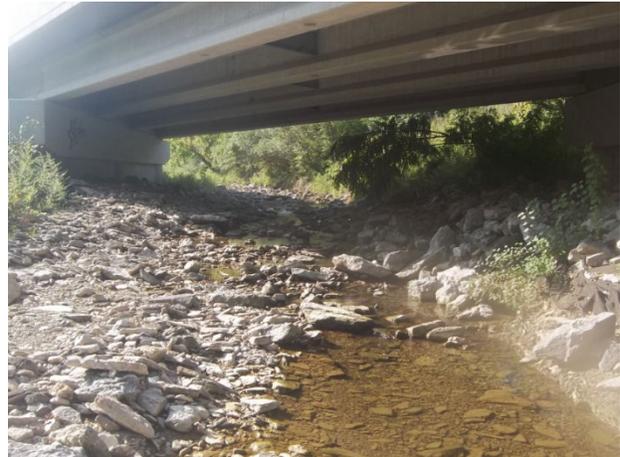
Photo 7. Threemile Creek 0.7

E. coli values ranged from 184 mpn/100ml to 8,660 mpn/100ml during Period 2 and ranged from 8 mpn/100ml to 14,140 mpn/100ml during Period 3 at THC0.7. The median values during both periods were above the 240 mpn/100ml criteria, 954 mpn/100 ml and 384 mpn/100ml.

The median bacteria value for each reporting period was highest within the Threemile Creek watershed when compared to the other watershed within the Central Basin. Suspected sources of elevated *E. coli* values within the Threemile Creek watershed primarily includes sewer overflows and storm water runoff.

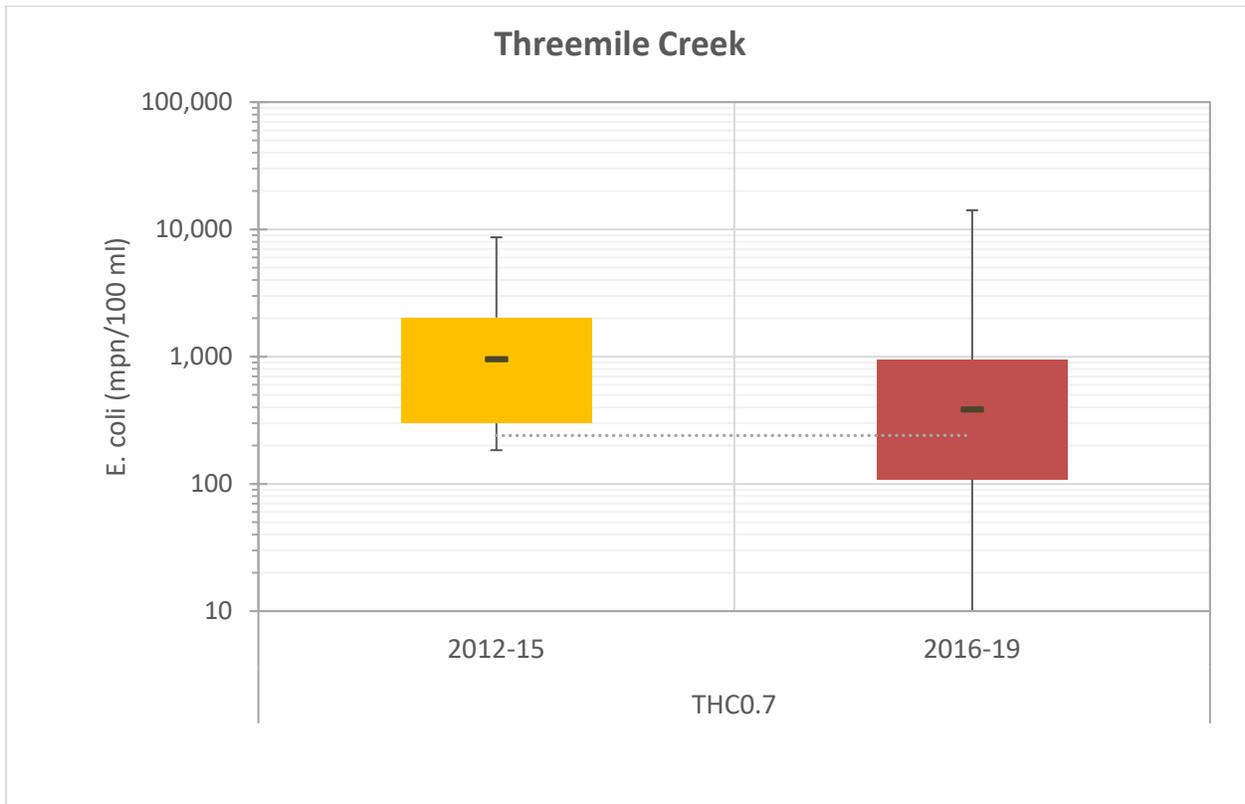
Note: The dashed line in the graph represents the single sample maximum criteria of 240 mpn/100ml.

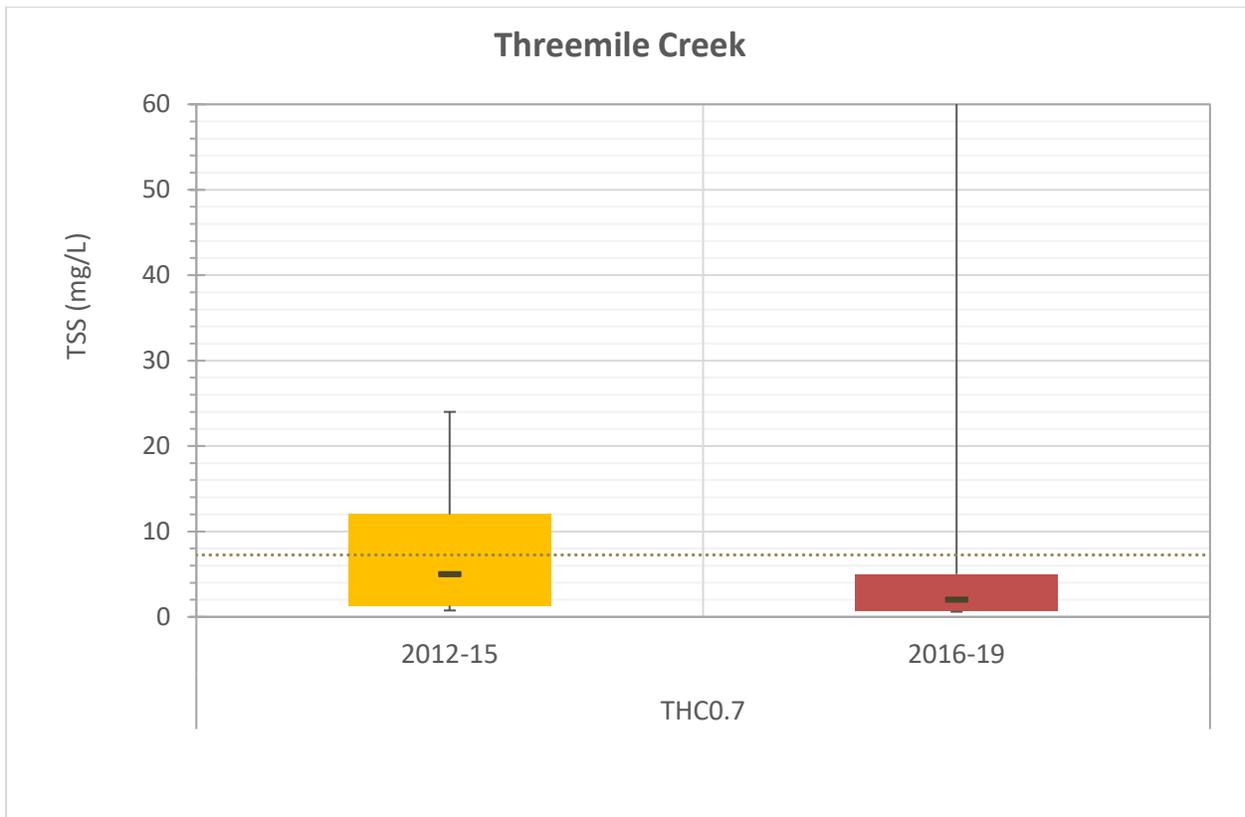
The median TSS value for each reporting period was lowest within the Threemile Creek watershed when compared to the other watershed in the Central Basin. Suspected sources of elevated TSS values within Threemile Creek watershed primarily includes storm water runoff and streambank erosion due to hydromodification.

Note: The dashed line in the graph represents the benchmark value established by KDOW of 7.25 mg/L.

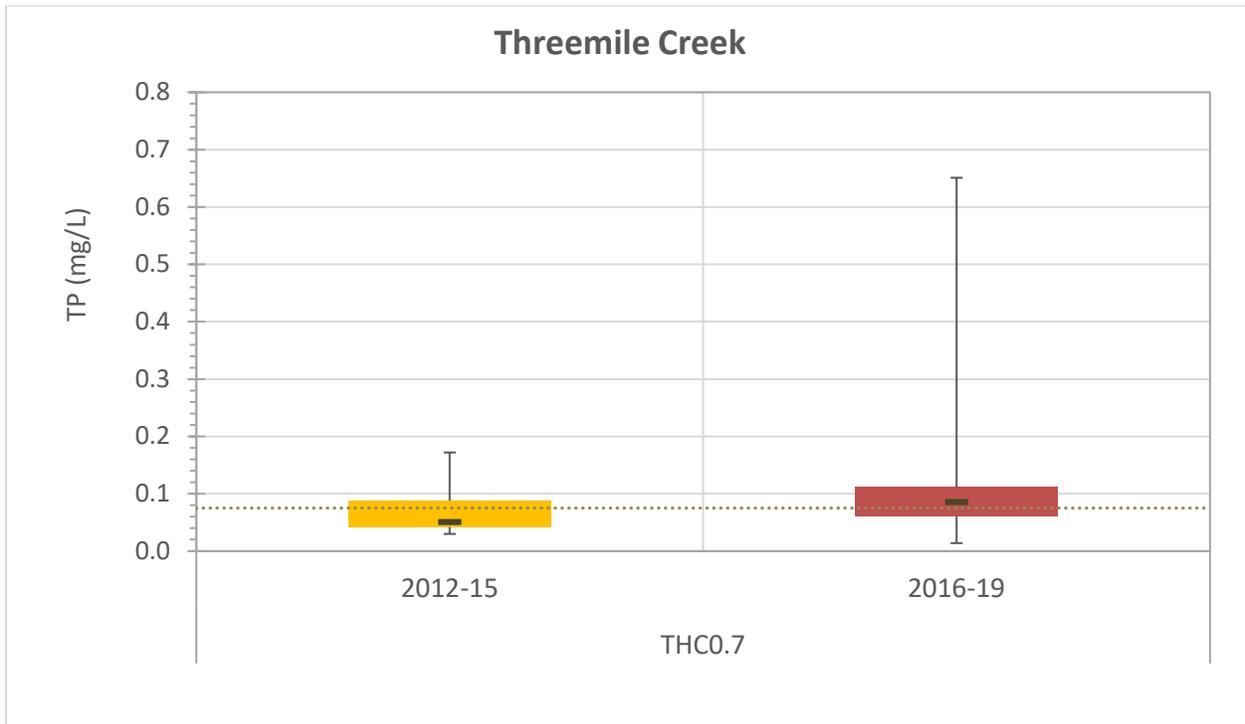
The median phosphorus value for each reporting period was lowest within the Threemile Creek watershed when compared to the other watershed in the Central Basin. The suspected sources of elevated phosphorus values within Threemile Creek watershed primarily includes sewer overflows and storm water runoff.

Note: The dashed line in the graph represents the benchmark value established by KDOW of 0.08 mg/L.

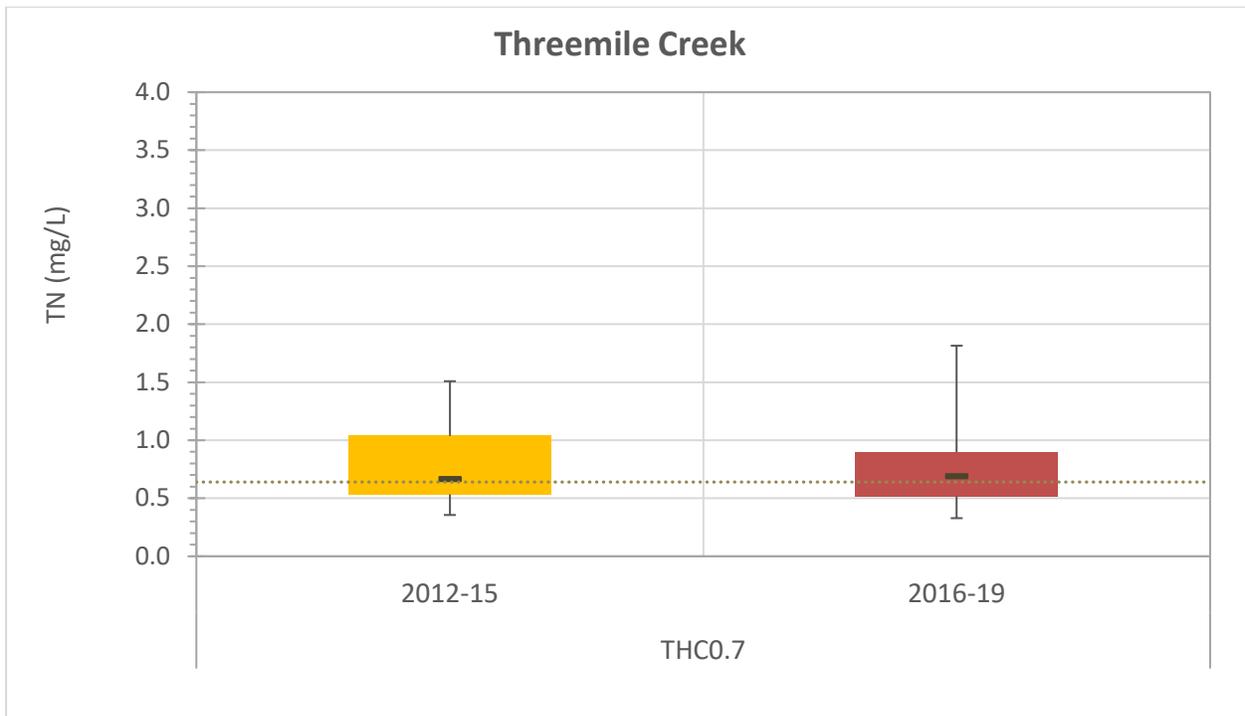
The median nitrogen value for each reporting period was lowest within the Threemile Creek watershed when compared to the other watershed in the Central Basin. The suspected sources of excess nitrogen values within Threemile Creek watershed primarily include storm water runoff.

Note: The dashed line in the graph represents the benchmark value established by KDOW of 0.6 mg/L.

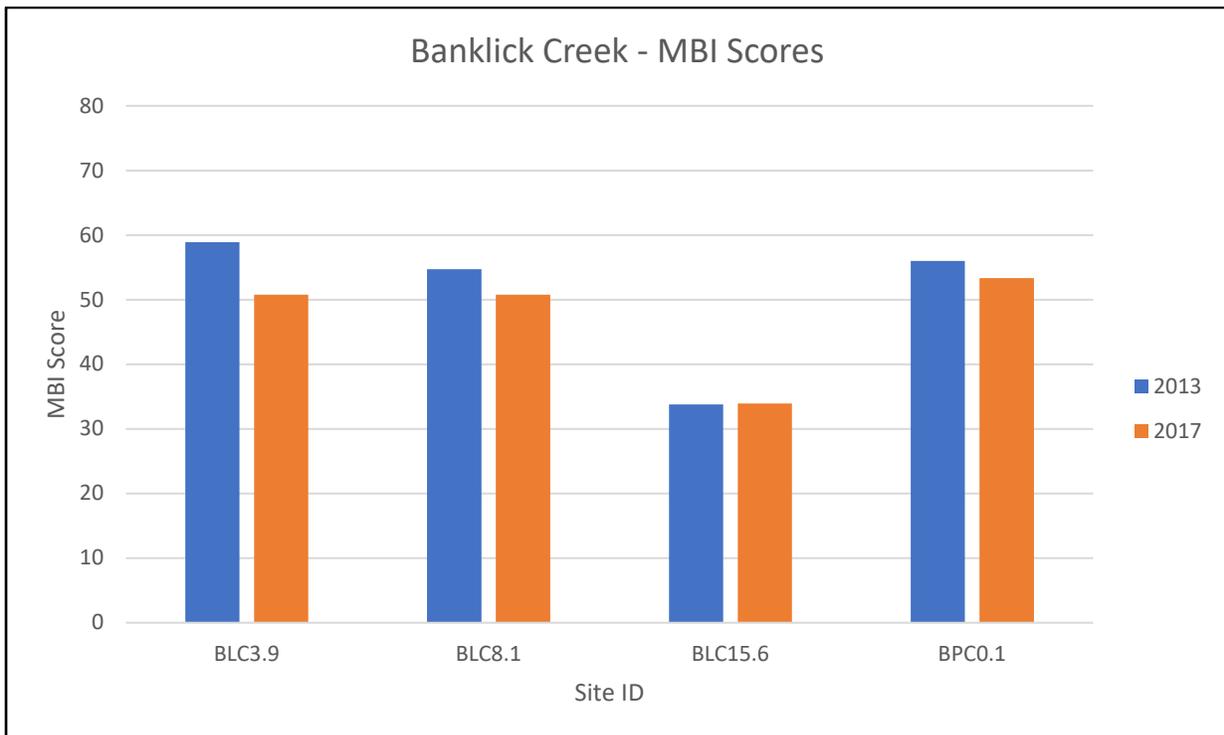
Figure 18. Banklick Creek MBI Scores

The Banklick Creek MBI scores ranged from fair to poor at all four sites. MBI scores for site BLC15.6 remained consistent, while scores for sites BLC3.9, BLC8.1, and BPC0.1 decreased from 2013 to 2017. This was primarily due to an increase in the percentage of pollutant tolerant organisms as well as a decrease in pollutant sensitive organisms.

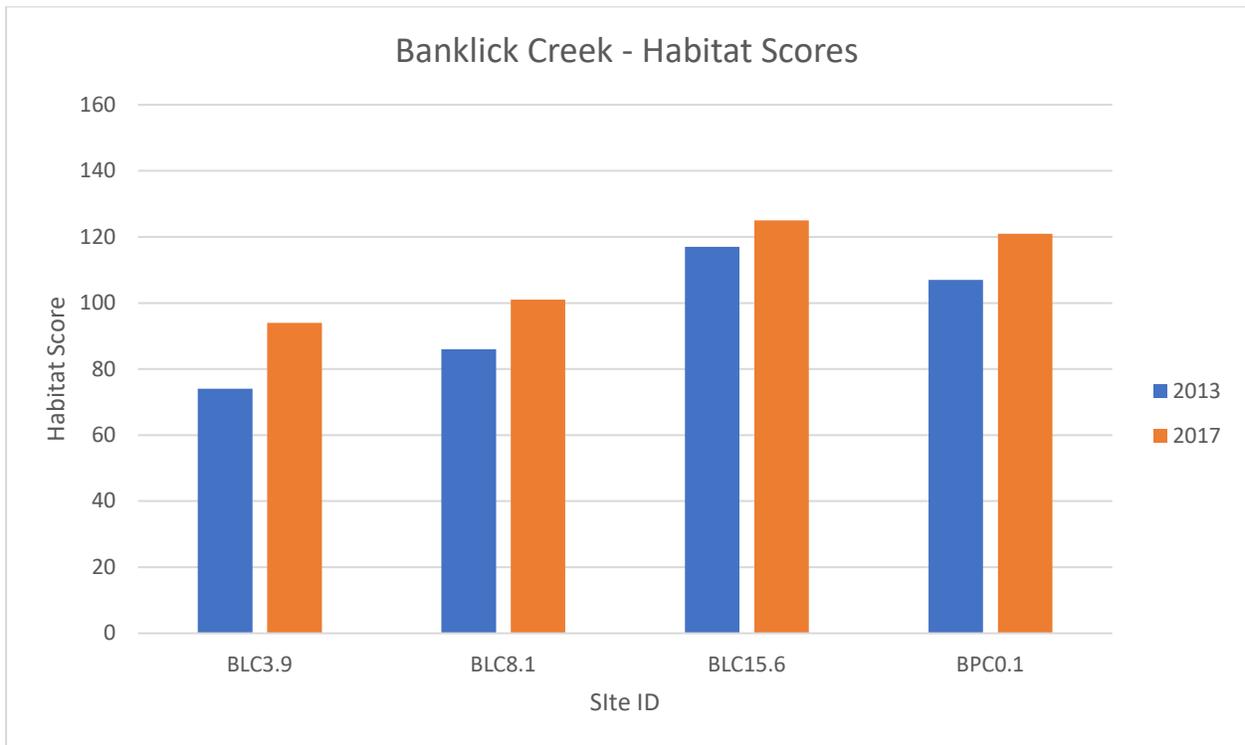
Figure 19. Banklick Creek Habitat Scores

The Banklick Creek habitat scores ranged from poor to fair at all four sites. Overall, each site’s habitat score increased, although all remained poor, except site BPC0.1 which improved to fair. Site BLC3.9 increased by 20 points, due to increases in embeddedness and bank and riparian vegetation metrics. Each site had an increase in bank stabilization and vegetation as well as sediment deposition (i.e., less fines present). However, three out of four sites recorded a decrease in frequency of riffles, while site BLC8.1 recorded an increase.

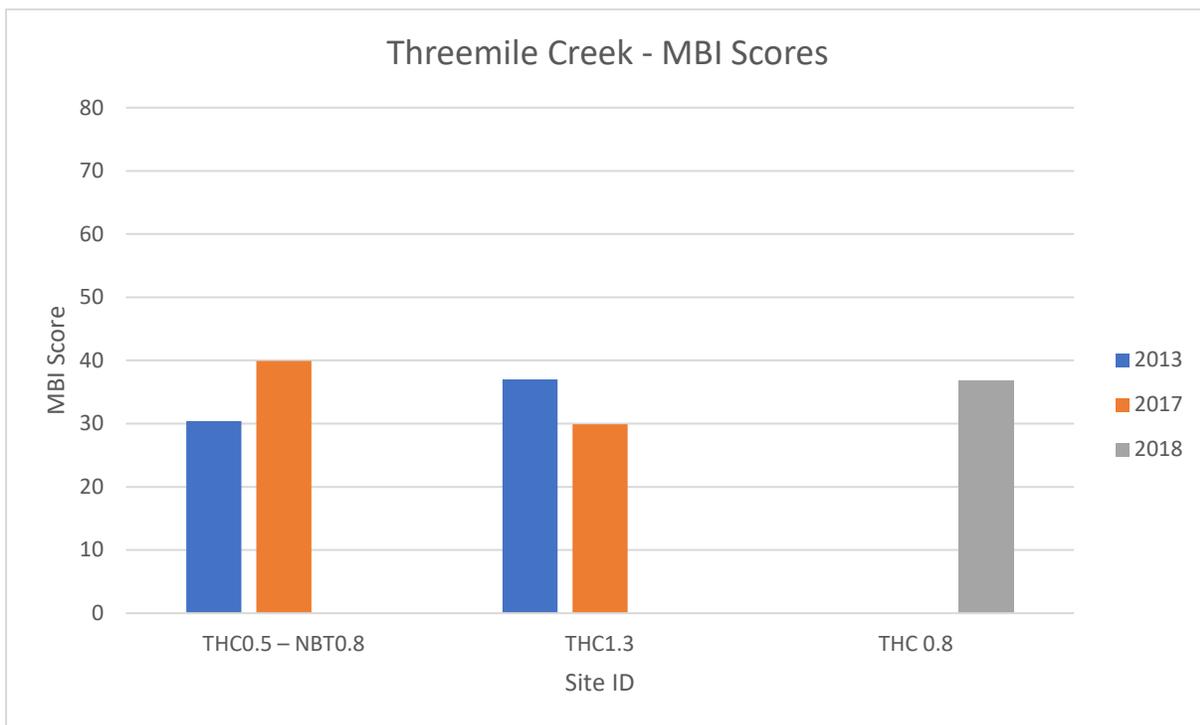
Figure 20. Threemile Creek MBI Scores

The Threemile Creek MBI scores were rated as poor or fair at all sites. The overall score at site THC0.5-NBT0.8 increased from 2013 to 2017, due to increases in pollutant sensitive organism metrics. The MBI score for site THC1.3 decreased from 2013 to 2017, due to a reduction in taxa richness and percentage increase in pollutant tolerant organisms.

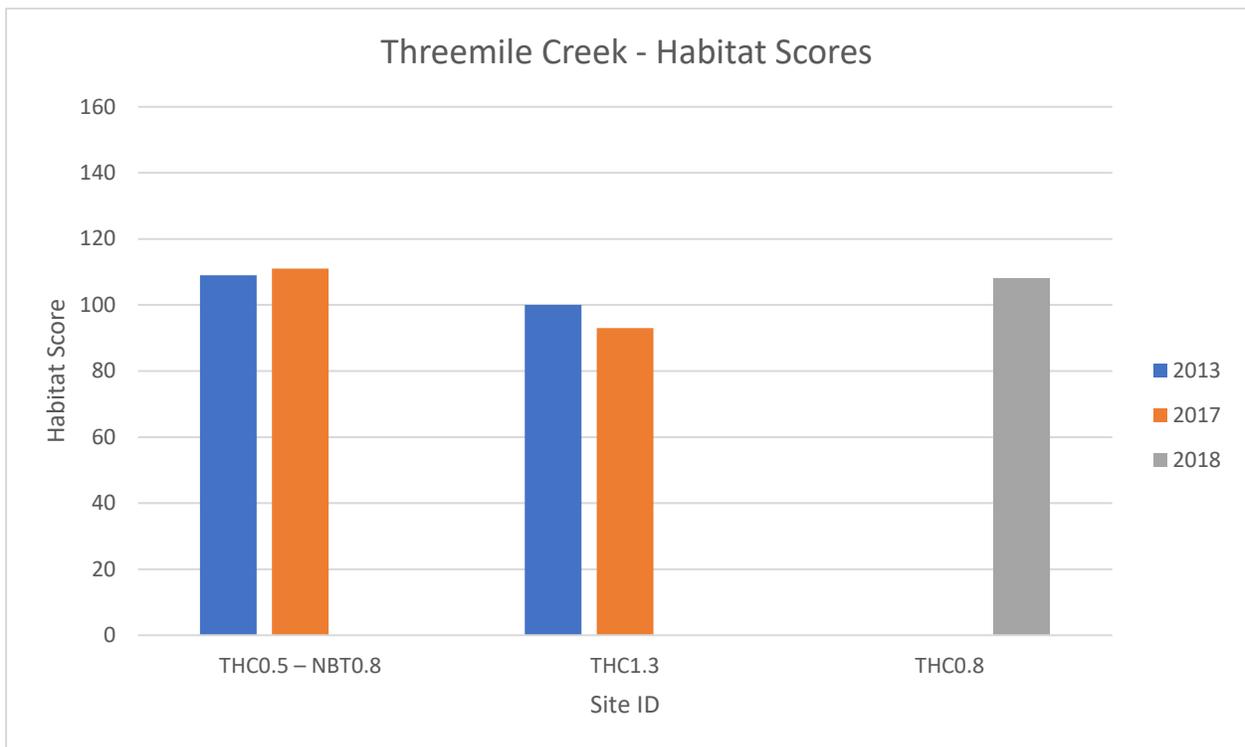
Figure 21. Threemile Creek Habitat Scores

The Threemile Creek habitat scores fluctuated at the sites from 2013 to 2017, however scores remained within the poor rating. Site THC0.5-NBT0.8 scores increased due to improvement in bank stability (left) and a marginal increase in embeddedness. While site THC1.3 scores decreased due to sediment deposition and channel flow status.

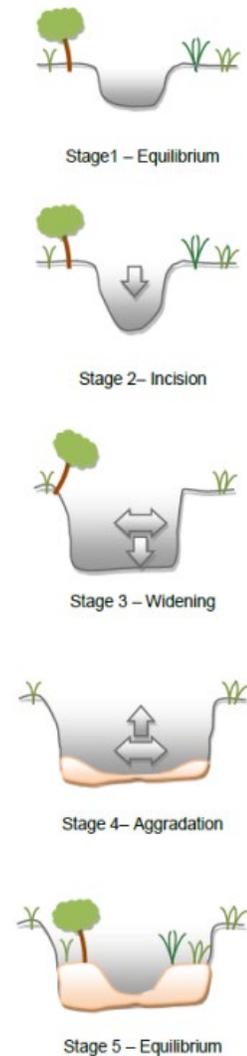
Figure 22. Channel Evolution Model¹²

Rapid Stability Scores measure rates of channel change, as seen in Figure 22 (figure shows the channel evolution model – illustration of how a stream can deepen, then widen, and reestablish new banks, over time), in conjunction with field indicators, failure mechanisms, and sediment transport analyses to develop a regionally calibrated channel stability index. The index scale (i.e., 0 – 10 scale) is designed to have built-in flexibility to score sites without detailed stream stability surveys on the same scale as those with multiple years of data using simple but significant metrics. There is not a definitive separation between scores, as in the MBI, however, as a guideline, Table 10 shows stability rankings (i.e., Stable, Transition and Unstable) with respect to assessment scores.

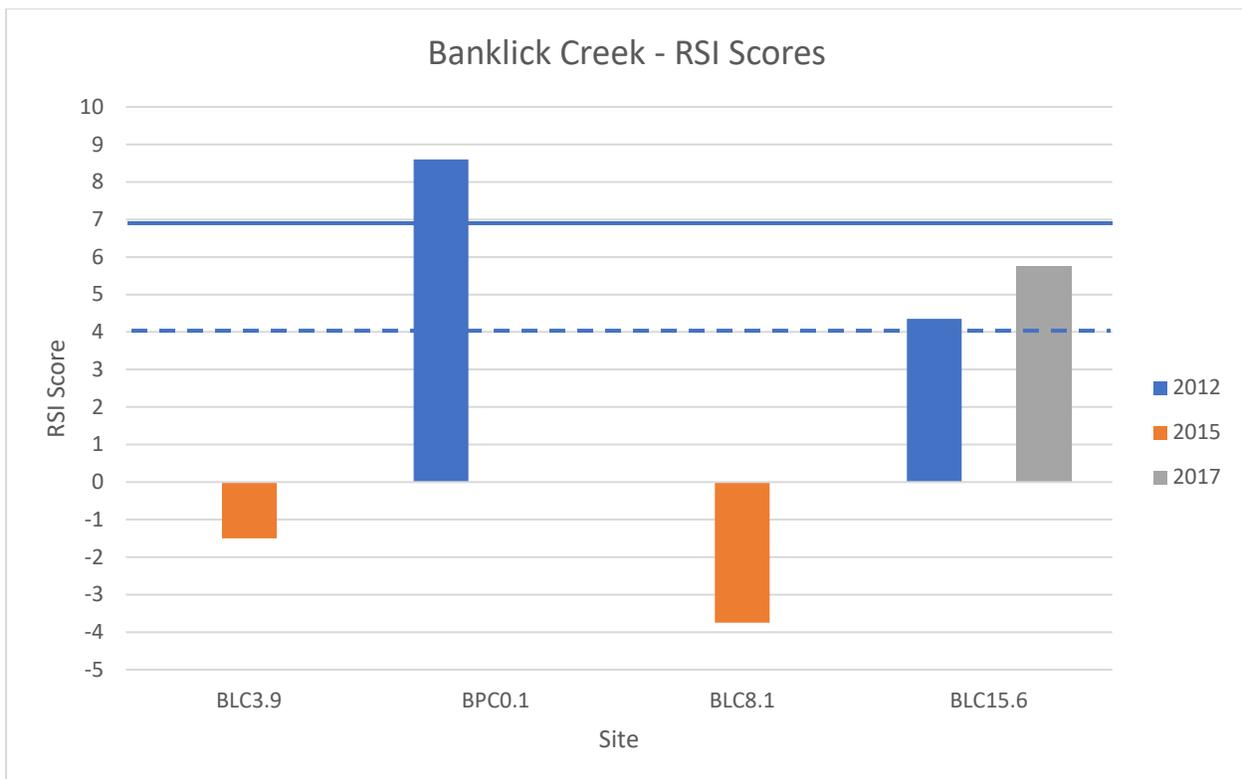
Figure 23. Banklick Creek Rapid Stability Scores

The monitoring sites in the Banklick Creek watershed depicted a variety of stability scores. Site BPC0.1 had a stable score in 2012, while both BLC3.9 and BLC8.1 had very unstable scores in 2015. Whereas site BLC15.6 was classified as transition, represented by the area between the solid and dashed blue lines in Figure 23, showing an increase in stability from 2012 to 2017. Evidence of sediment transport and some erosion can be seen in the site photos that follow.

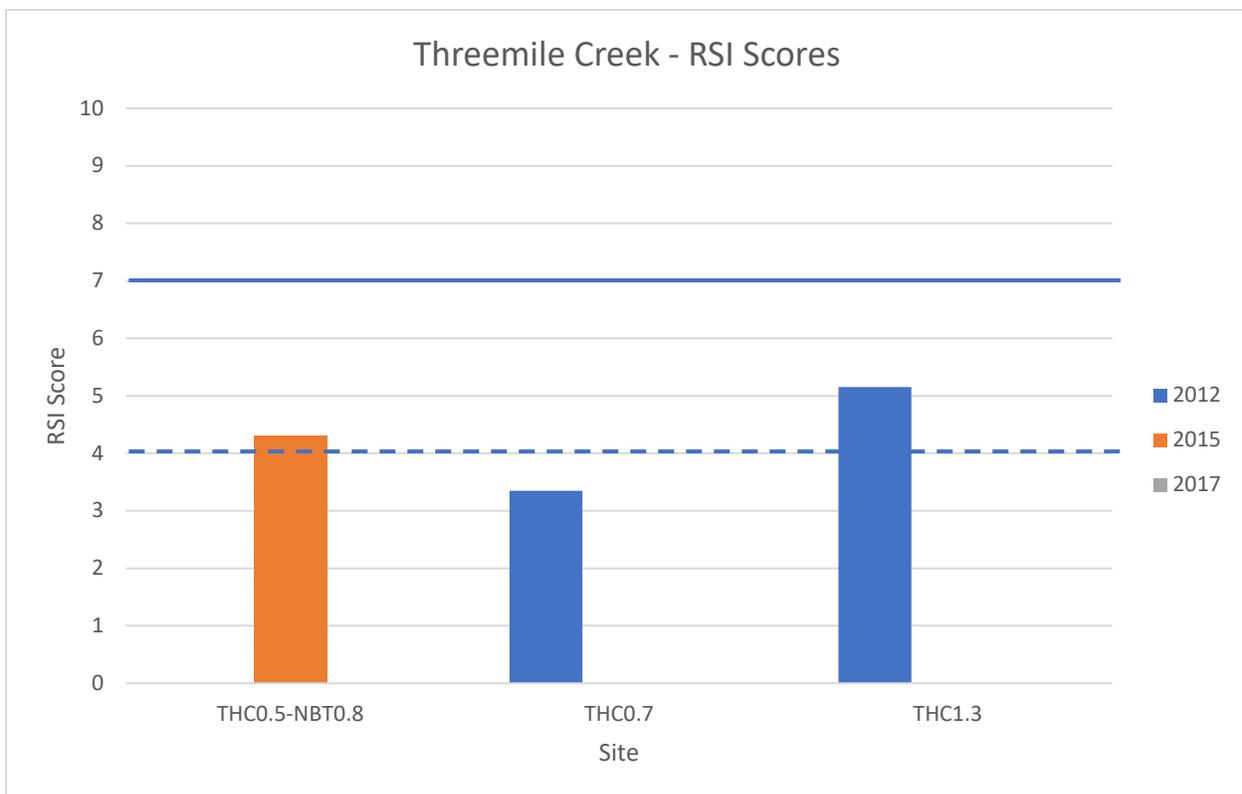
Figure 24. Threemile Creek Rapid Stability Scores

The monitoring sites in Threemile Creek watershed were all below the stable threshold score of 7, however sites THC1.3 and THC0.5-NBT0.8 were within the transition zone, as represented by the area between the solid and dashed blue lines in Figure 24. Site THC0.7 depicts an unstable score, primarily due to bank angle and height.
