WATERSHED TREND REPORT

CENTRAL STUDY BASIN

2012 - 2019

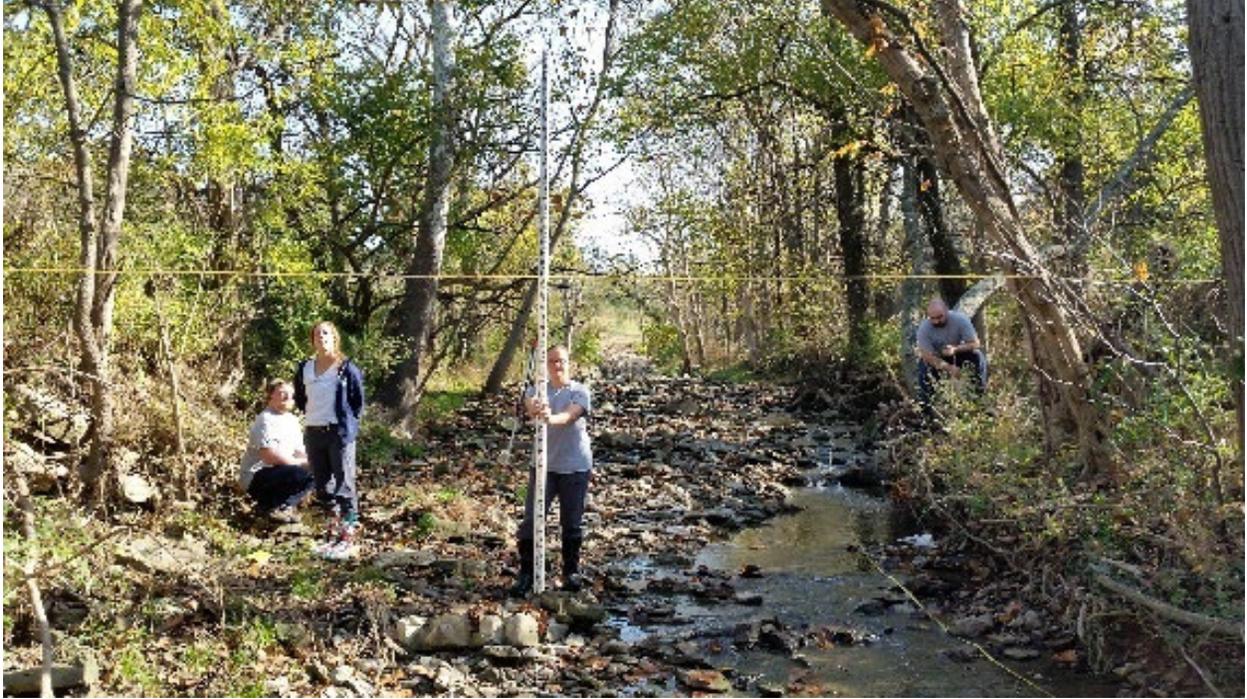
Photo 16. North Branch of Threemile Creek 0.8

The monitoring sites in Threemile Creek watershed were all below the stable threshold score of 7, however sites THC1.3 and THC0.5-NBT0.8 were within the transition zone, as represented by the area between the solid and dashed blue lines in Figure 24. Site THC0.7 depicts an unstable score, primarily due to bank angle and height.

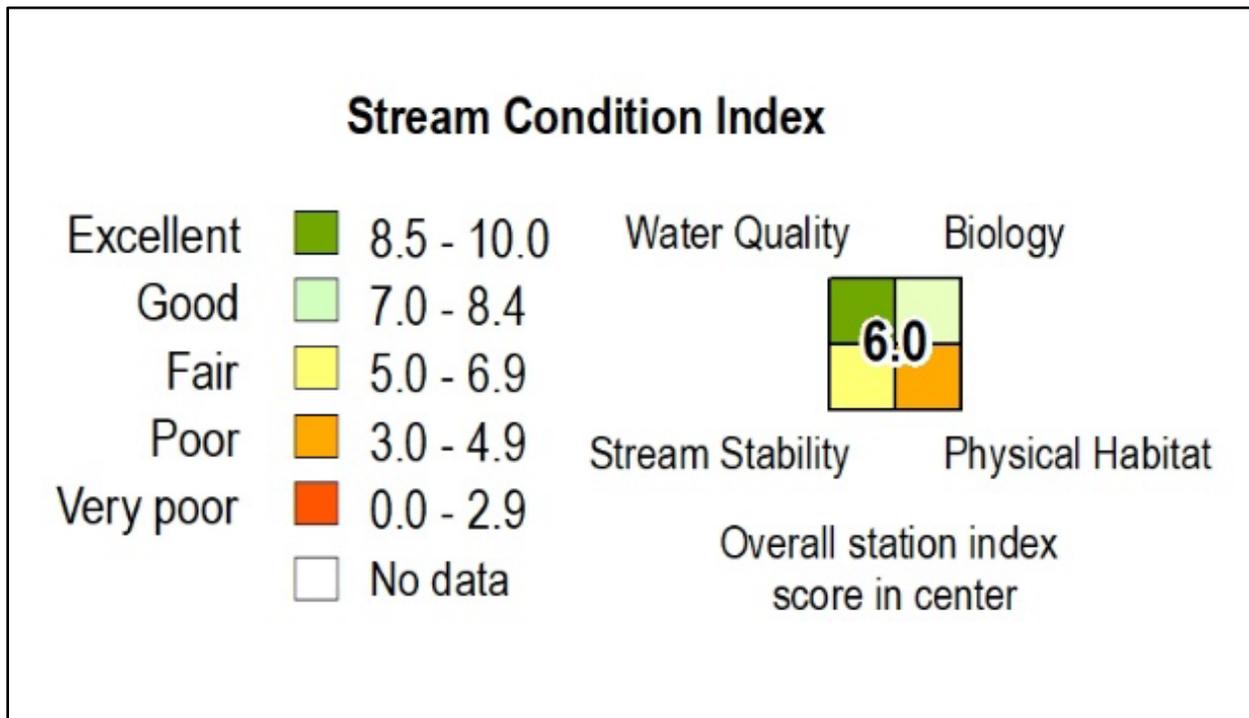
Figure 25. Stream Condition Index Visual Representation

The Stream Condition Index (SCI) is a visual representation (Figure 25) of four key components of SD1’s watershed assessment program: water quality, biology, physical habitat, and stream stability¹³. Originally developed for a tool to summarize large amounts of complex information that can be easily understood by the general public, the SCI was updated in 2020 for trend analysis¹⁴. Each of these four components is essential to fully understand the ecological functions and relative health of the individual streams. Relying on a single parameter could be problematic since some streams may rate well in one category, but poor in others. Each of the four indicators used in the Stream Condition Index are given sub-scores. The four sub-scores are then averaged to generate a single overall Stream Condition Index score. These scores are updated as additional data is collected and as the characterization of the watersheds are refined. The overall score for a monitoring site is only calculated if 3 out of the 4 indicators are populated with a sub-score.

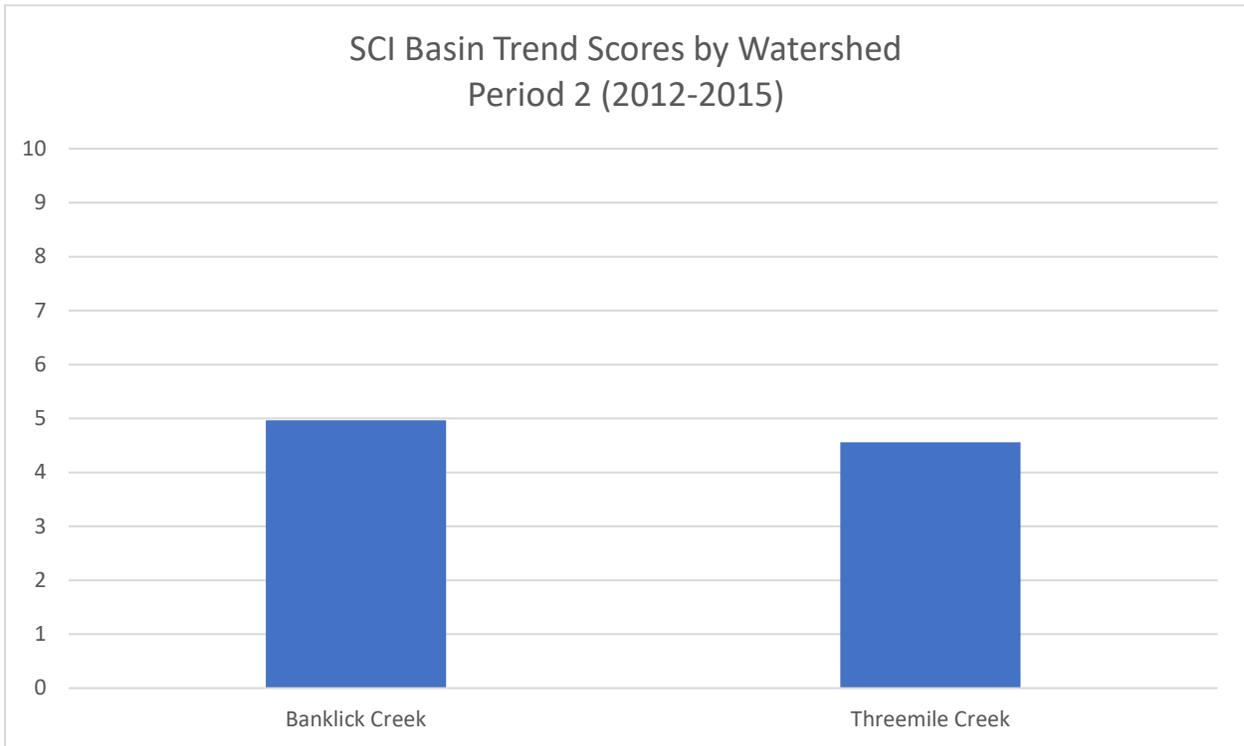
Figure 26. Stream Condition Index Basin Trend Scores by Watershed for Period 2

Watershed	Water Quality Score	Biology Score	Habitat Score	Stream Stability Score	Score
Banklick Creek	6.26	6.40	3.96	3.24	4.97
Threemile Creek	5.88	4.37	3.71	4.27	4.56

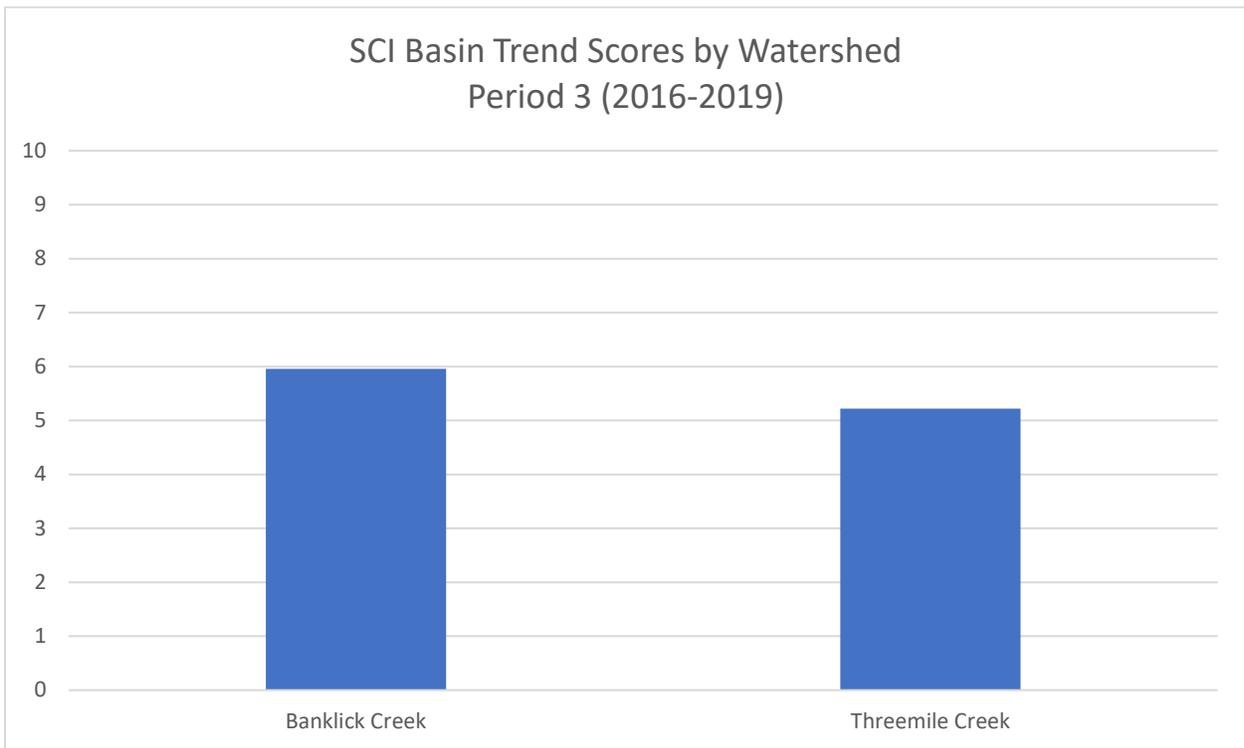
Figure 27. Stream Condition Index Basin Trend Scores by Watershed for Period 3

Watershed	Water Quality Score	Biology Score	Habitat Score	Stream Stability Score	Score
Banklick Creek	7.09	5.94	5.04	5.75	5.96
Threemile Creek	7.35	4.62	3.69	NA	5.22

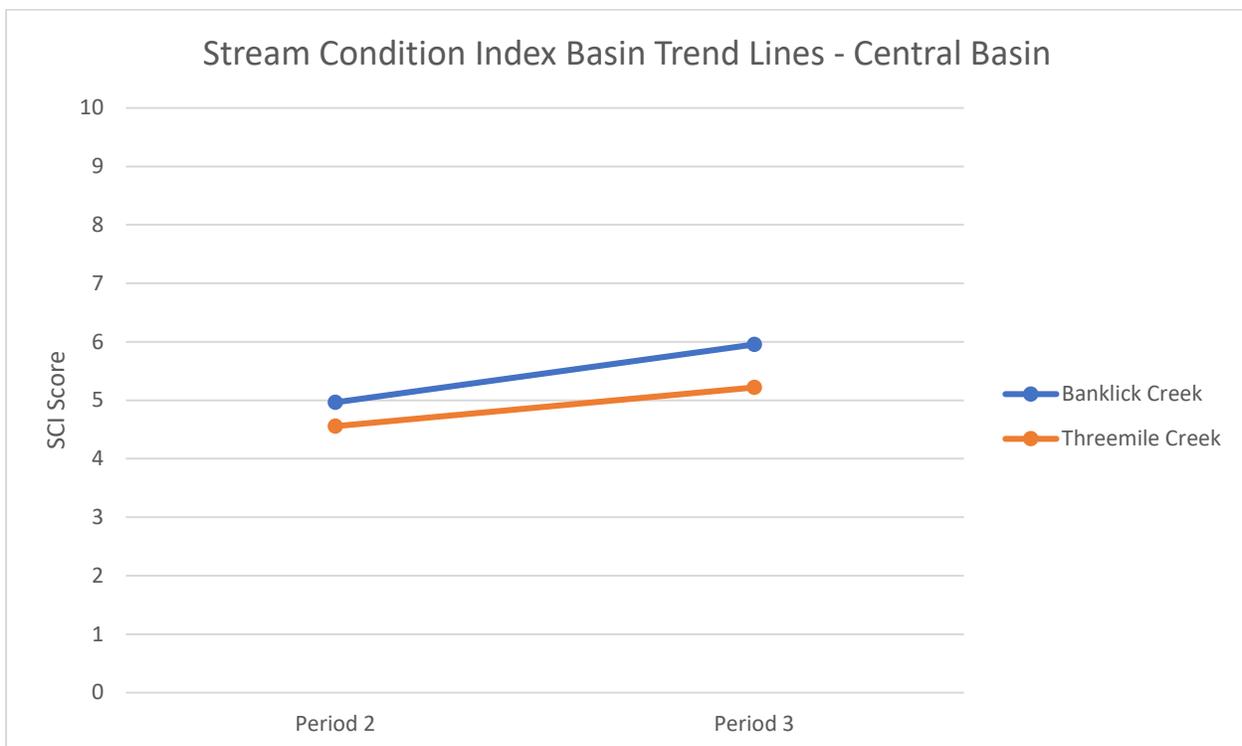
Figure 28. Stream Condition Index Basin Trend Scores

Table 15 and Figure 28 depict the initial points of a trend line representing SD1's Stream Condition Index for the two watersheds in the Central Basin. Although data was limited at some monitoring sites within the watersheds during Periods 2 and 3, a more complete dataset starting with Period 4 will increase the accuracy of the analysis.

Watershed	Period 2 (2012-2015)	Period 3 (2016-2019)
Banklick Creek	4.97	5.96
Threemile Creek	4.56	5.22
