Sanitation District No. 1
January 30, 2015

Consent Decree
Quarterly Report No. 29
(October 1, 2014 through December 31, 2014)

CONSENT DECREE QUARTERLY REPORT NO. 29

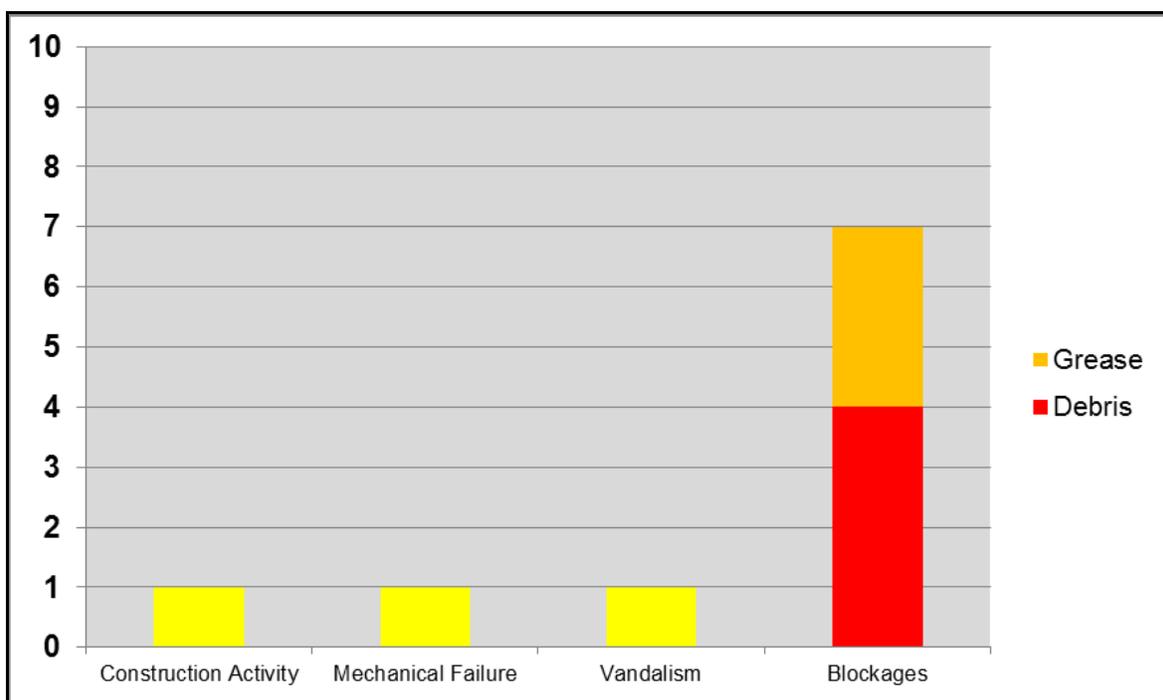
Figure 2.1 Occurrences of SSO Due to Operational Issues per Cause
 (October 1, 2014 through December 31, 2014)

During the fourth quarter of 2014, there were a total of 10 SSOs due to operational issues throughout SD1's service area. A total estimated overflow volume of 82,900 gallons was discharged during these incidents. Figure 2.1 demonstrates the primary causes of the overflows and Figure 2.2 demonstrates the corresponding volumes.

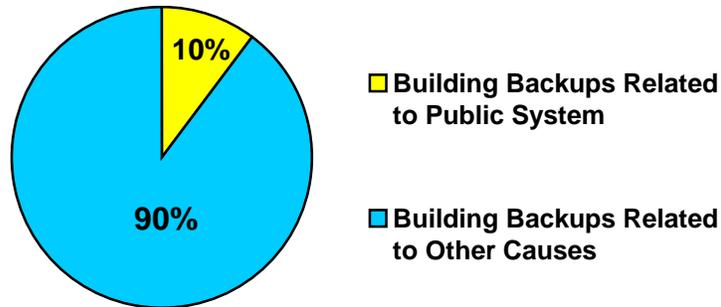
Figure 2.3 Building Backups: Public System vs. Other Causes
(October 1, 2014 through December 31, 2014)

to the condition or operation of the public sewers and 104 were caused by other issues, as shown in Figure 2.3. The building backups determined not to be related to the condition or operation of the public sewers, were caused by blockages in private service laterals and internal plumbing issues.

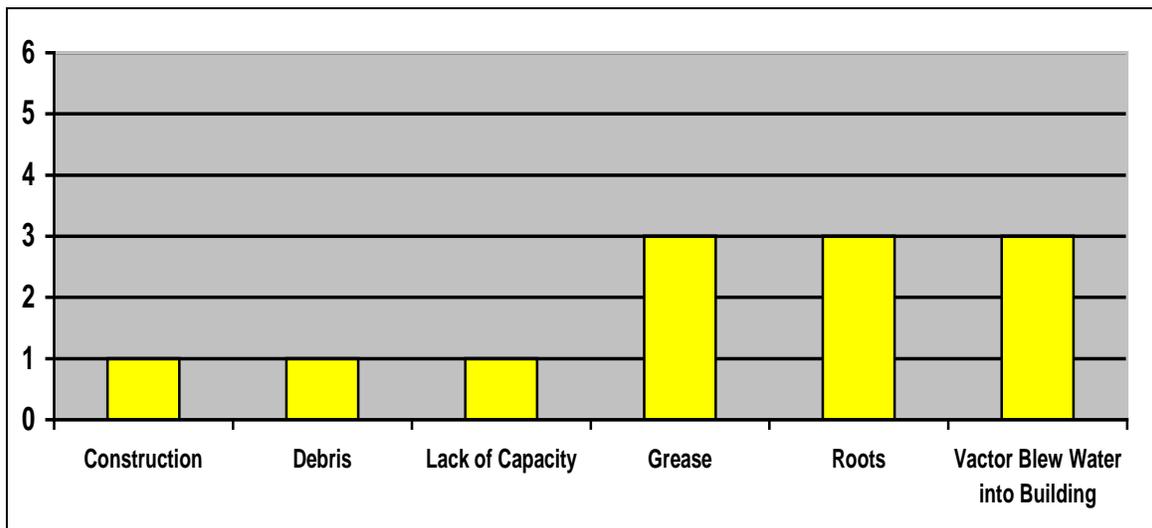
Figure 2.4 Occurrences of Public System Related Building Backups per Cause
(October 1, 2014 through December 31, 2014)

The causes of the approximate 12 building backups determined to be related to the condition or operation of the public sewer lines are detailed in Figure 2.4.

The sewers where these blockages occurred were put into or updated in SD1’s CSAP to be inspected and cleaned, as determined by the program logic, which also provides appropriate next actions to permanently address the cause of the blockages.

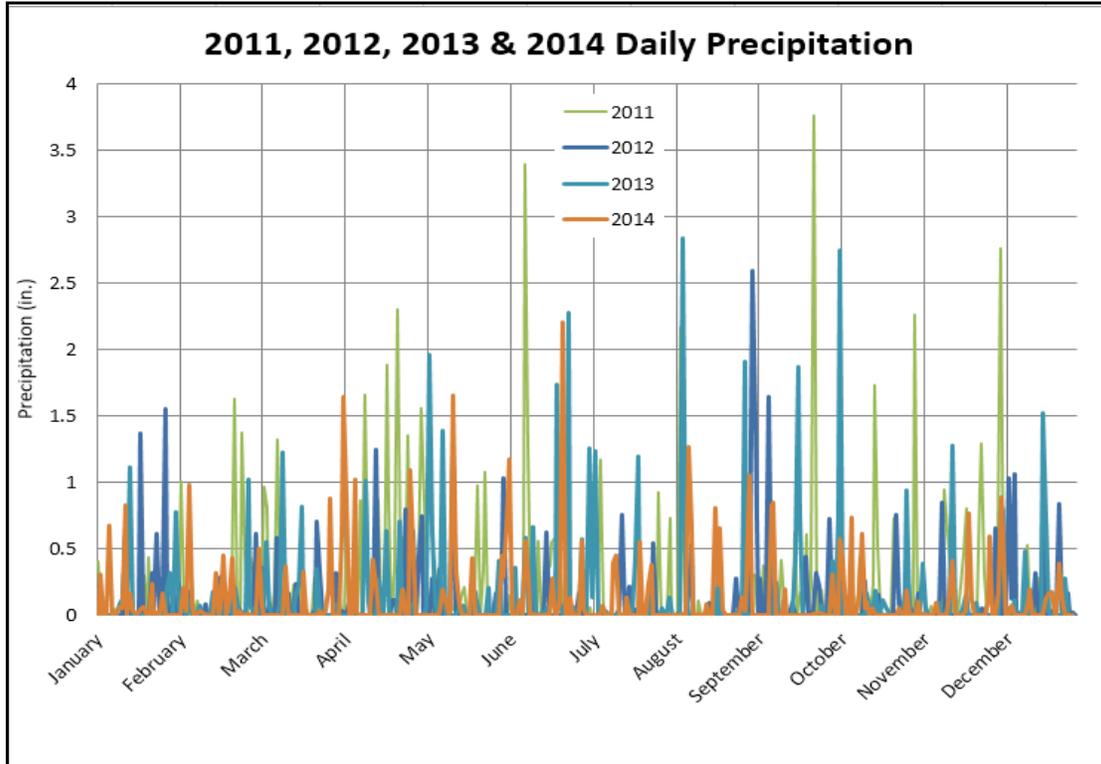
Figure 3.1 Daily Precipitation (2011 through 2014)

The rainfall volume data in Tables 3.1 and 3.2 are based on total rainfall data recorded at the Cincinnati-Northern Kentucky International Airport (CVG). The storm event data is based on an estimate of the number of events observed at the rain gauges within the SD1 system. An event is defined as a period of time where rainfall is bracketed by at least seven hours of no rainfall. The daily precipitation statistics in Figures 3.1 and 3.2

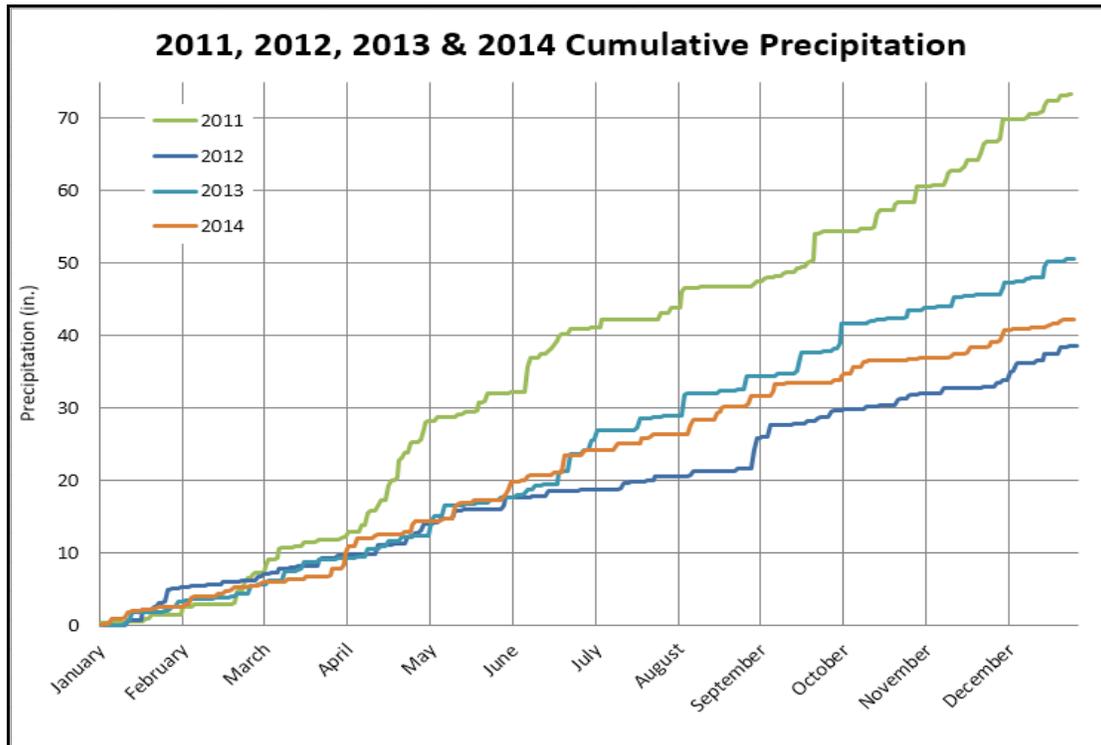
Figure 3.2 Cumulative Precipitation (2011 through 2014)

From 2013 to 2014, the cumulative rainfall depth decreased 17 percent, while the number of rainfall events increased by 10 percent. This indicates that, on average, storms had lower intensities in 2014 than in 2013. The most intense storm observed in 2014 was a 2-year-48-hour event in April. The cumulative depth of rainfall in 2014 of 42.2 inches is very close to what would be expected, and only slightly higher than the typical year rainfall amount of 40.8 inches. Reviewing rainfall over the past several years reveals that totals in 2014 and 2012 tracked closely to the typical year, 2013 was wetter than normal, and 2011 was a record-setting wet year. The 2014 average storm size was 0.38 inches per storm, which is 5 percent lower than the typical year average of approximately 0.40 inches per storm and 24 percent lower than the previous year's 0.50 inches per storm. The 2014 average storm is the lowest in the past five years, which underscores the relevance of this statistic in the overflow results presented in the following sections. A discussion and summary of the above presented information and how it relates to changes in overflow frequency and volume is included in Section 3.2 of this report.

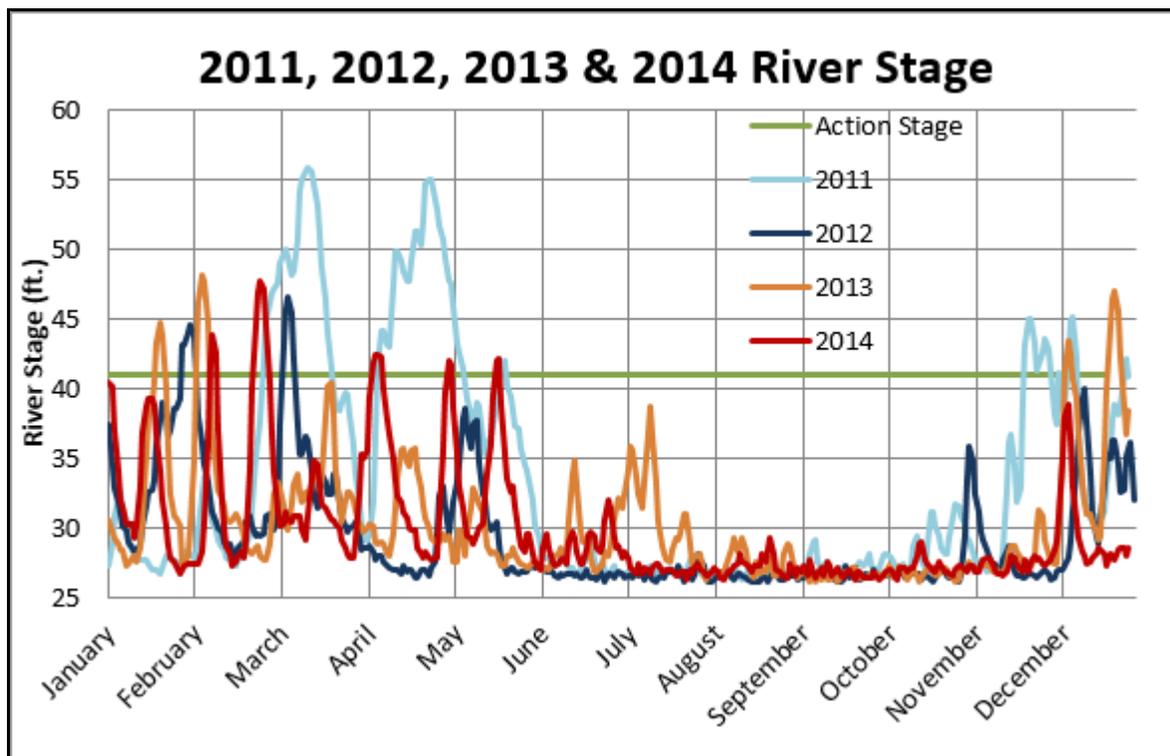
Figure 3.3 Daily River Stage (2011 through 2014)

SD1's system is influenced in multiple ways by the local Ohio River stage level. In addition to increasing groundwater levels that cause additional infiltration to occur, SD1's system operation is also impacted when the river stage is above 41 feet, as shown in Figure 3.3. When the Ohio River reaches the Army Corps of Engineers' specified river stages during flood conditions, CSO outfall flood gates are closed to isolate the sewer system from high river water. Other sewer system flood gates are opened or closed to isolate portions of the interceptor and combined sewers to re-route sewer flows to the flood pumping stations. The flood pumping stations and gates were designed to operate by the Army Corps of Engineers to protect the cities from flooding internally due to elevated river levels, or during rain events when the flows in the combined sewers cannot flow out into the river due to the elevated river levels. SD1 continues to work on eliminating river water intrusion through a program to install duckbill-style check valves on CSO outfalls, effective up to river levels of 47 feet.

Table 3.3 shows the number of days each quarter that the river stage exceeded 41 feet from 2011 to 2014. The Ohio River is at or above 41 feet for 26 days of the year, based upon the daily river stage average from 1970 to 2005.

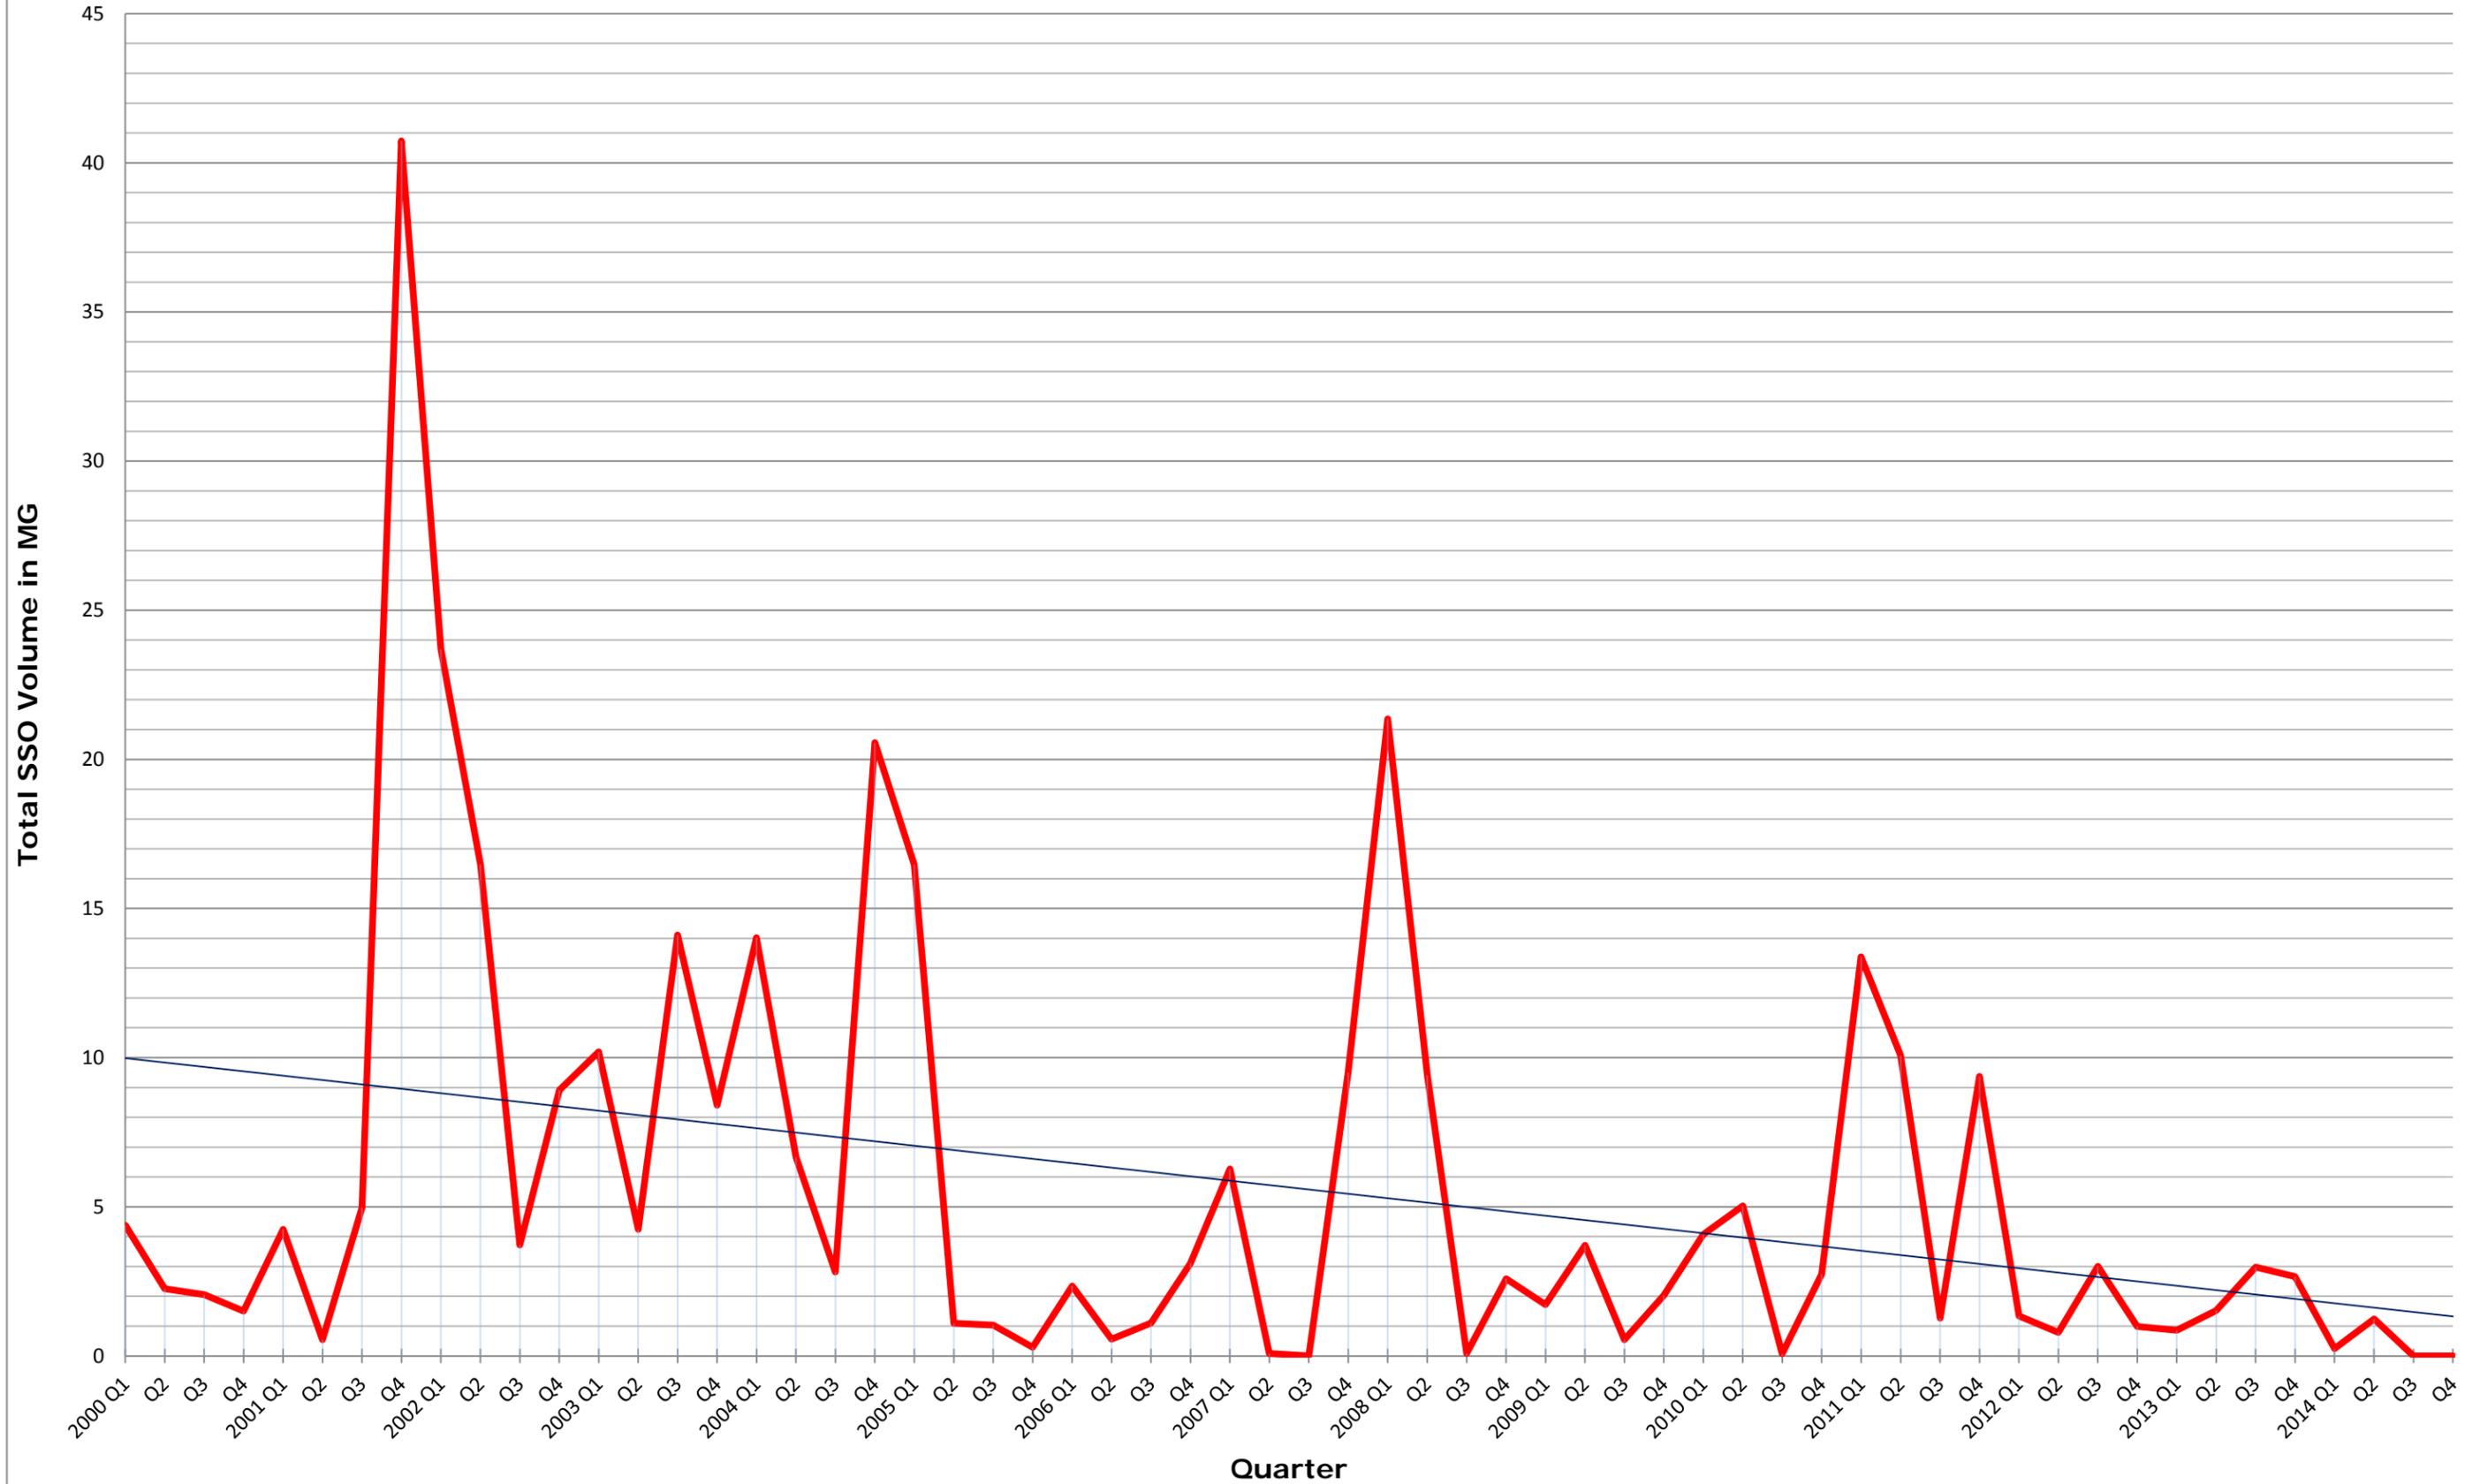
Lakeview Pump Station Overflow Due to a Lack of Capacity during Wet Weather

Excludes SSO Volumes Due to Operational Issues

Table 2.2 lists each of the 14 pump stations identified in Exhibit E of the Consent Decree and their wet-weather SSO activity during the current reporting period. This is the first quarter since SD1 entered into the Consent Decree in 2007 that no wet-weather SSOs were observed at the 14 pump stations listed in Exhibit E. Additionally, this is the second consecutive quarter and eighth consecutive month that a wet-weather SSO has not occurred at the Lakeview Pump Station. A graph highlighting the quarterly decline

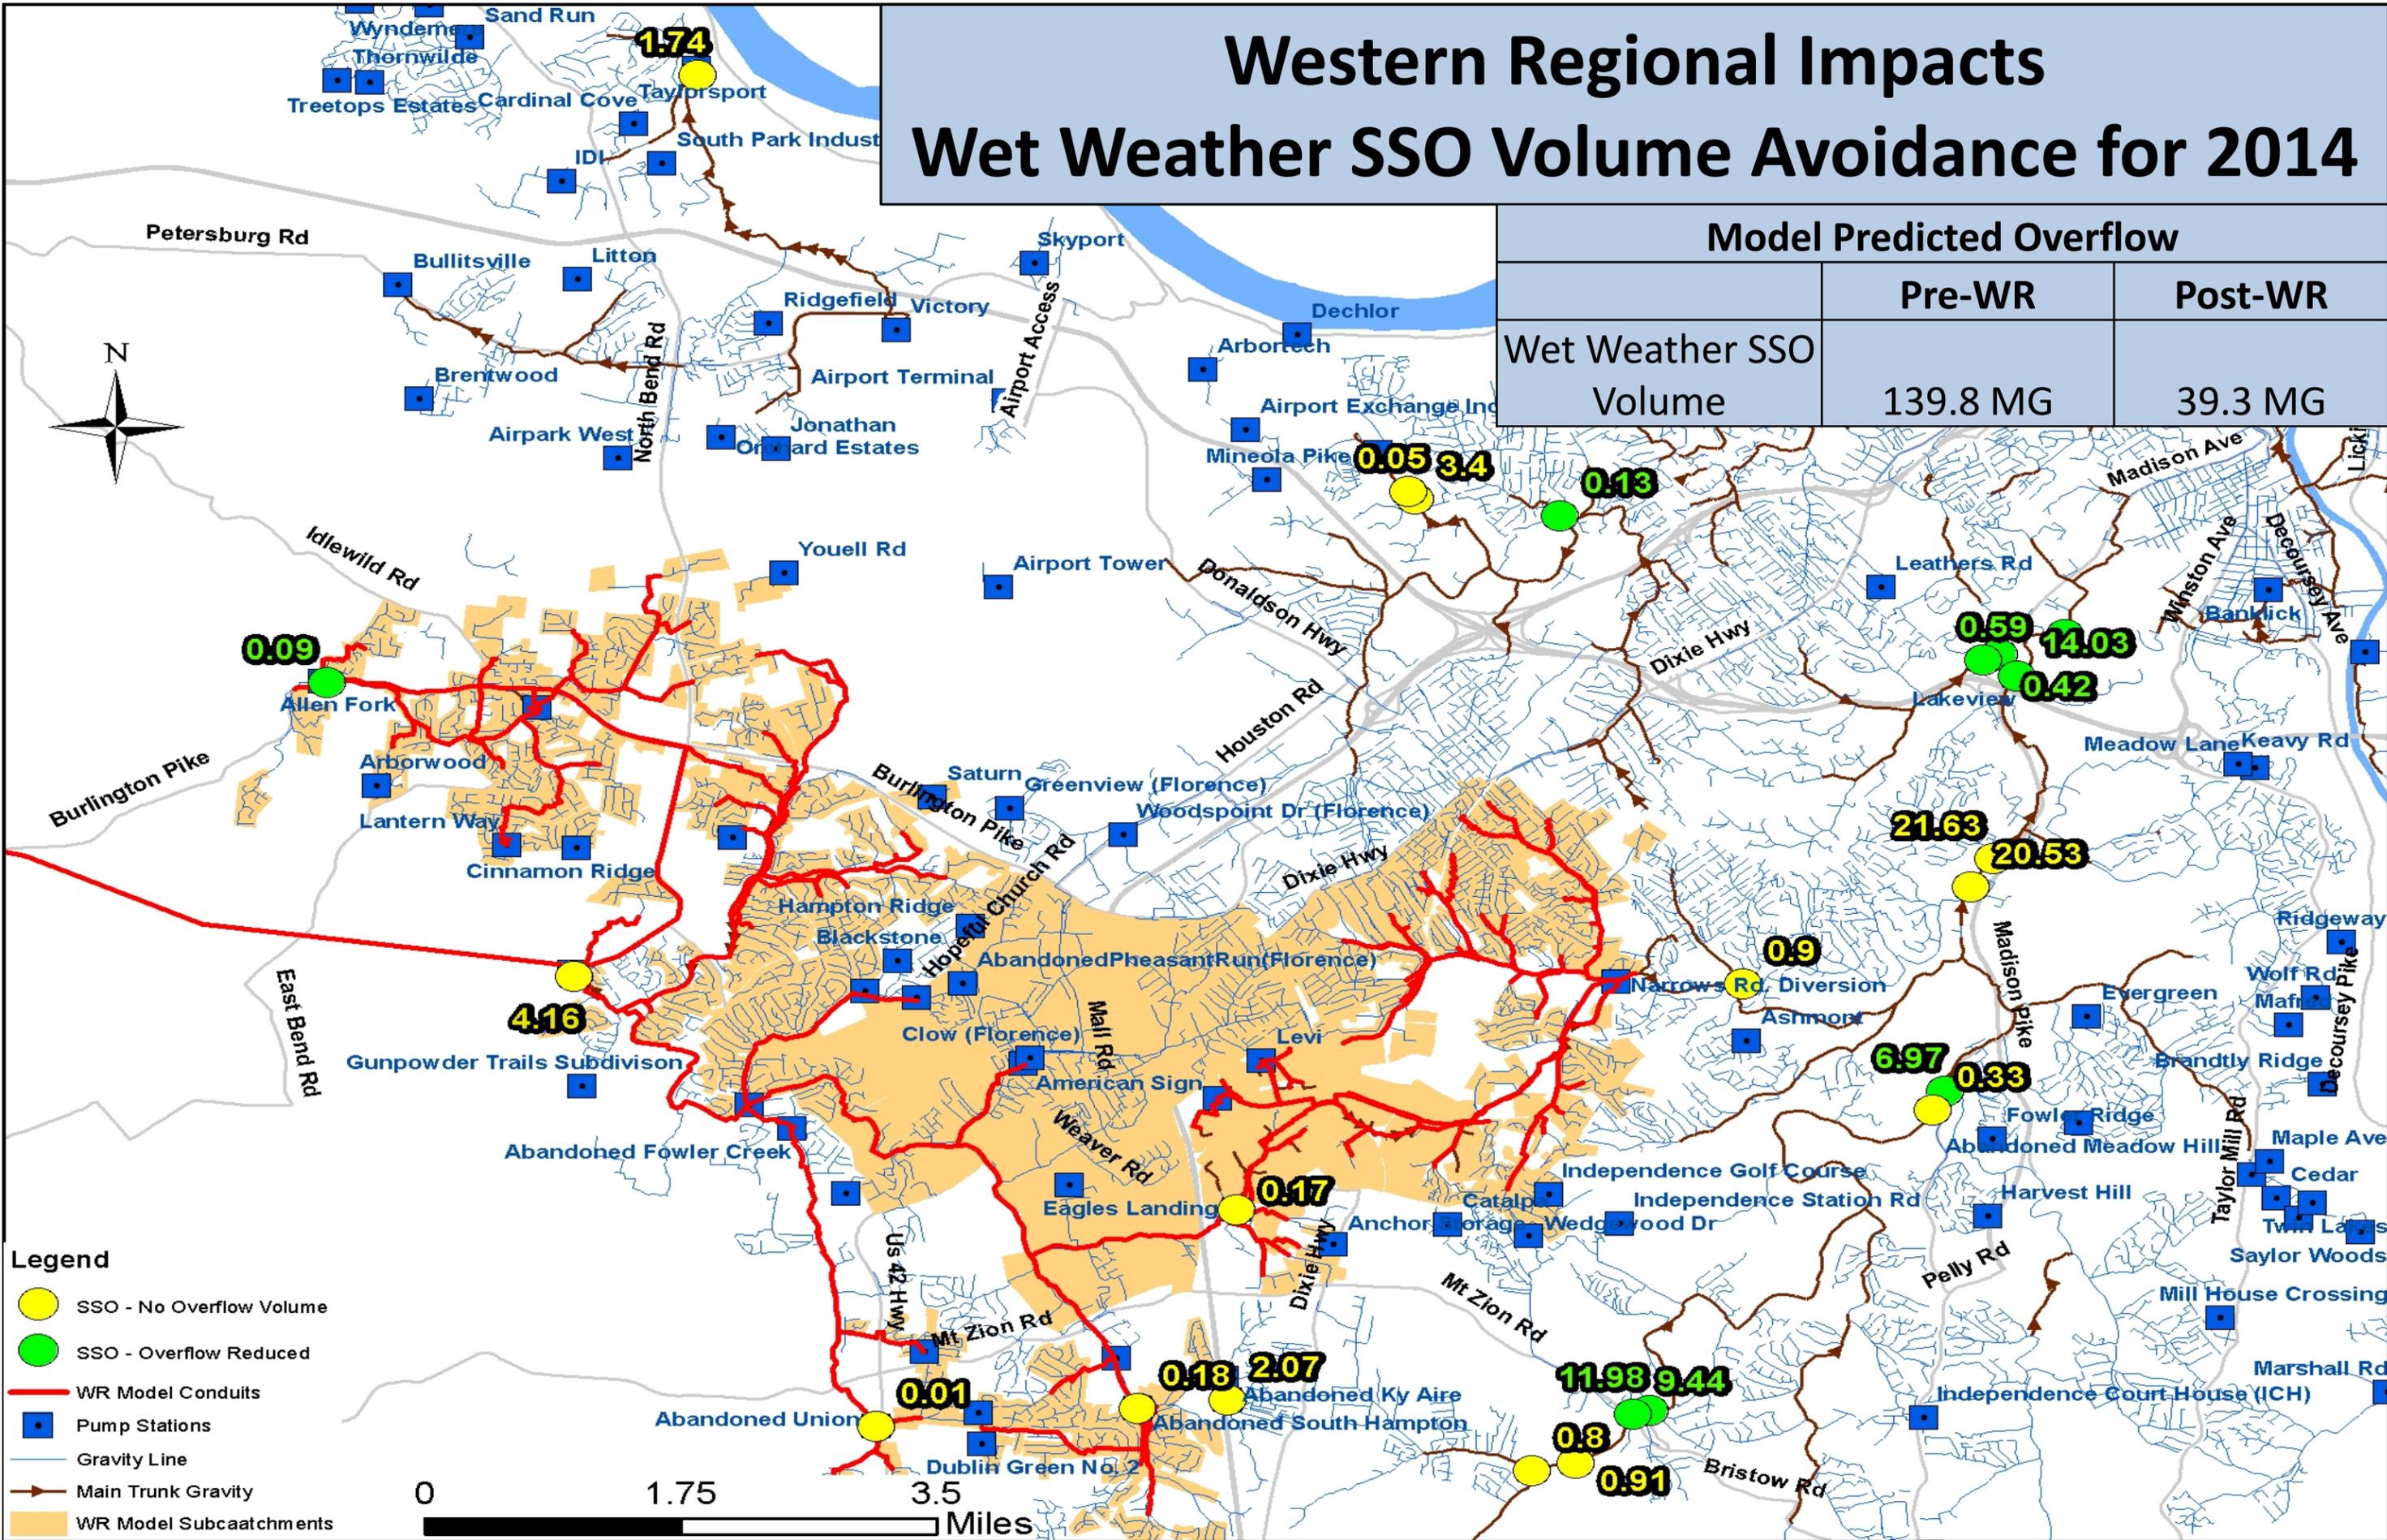
Wet Weather SSO Volume Avoidance for 2014

Model Predicted Overflow		
	Pre-WR	Post-WR
Wet Weather SSO Volume	139.8 MG	39.3 MG
